FINAL TOWN WIDE FACILITIES PLAN

TOWN OF EXETER

SPACE NEEDS AND BUILDING ASSESSMENTS

EXETER, NEW HAMPSHIRE

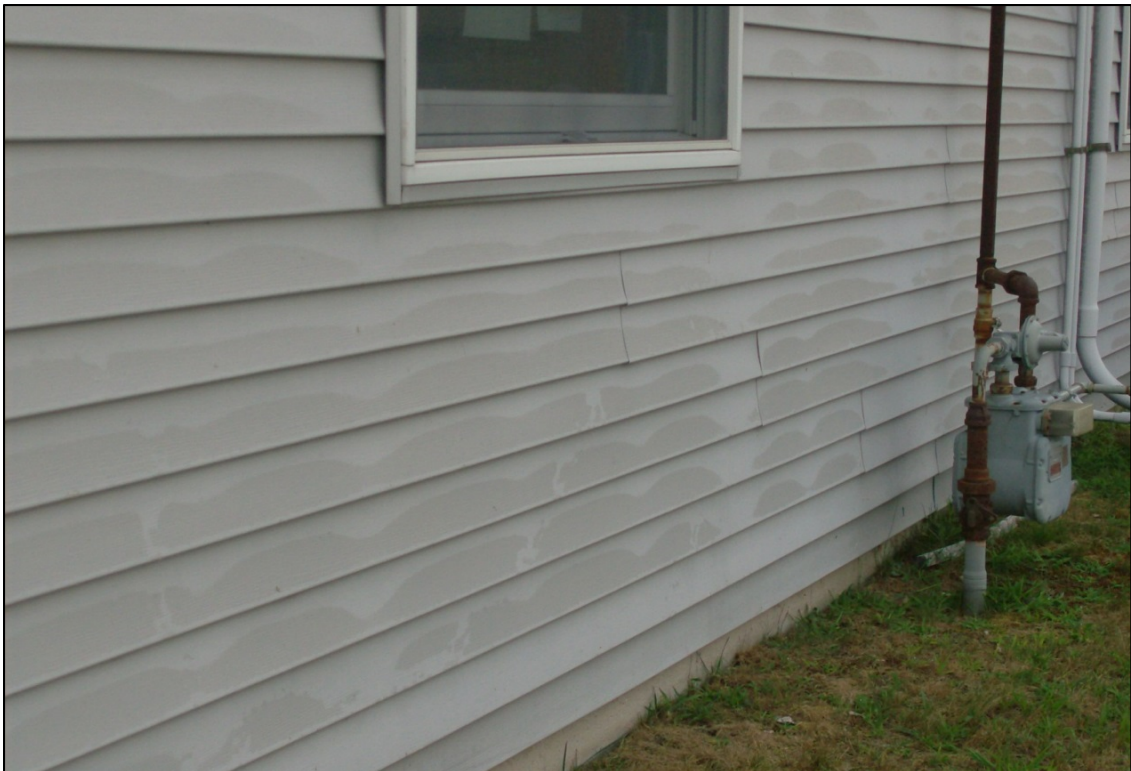
Condensation formed early morning on south side of building.

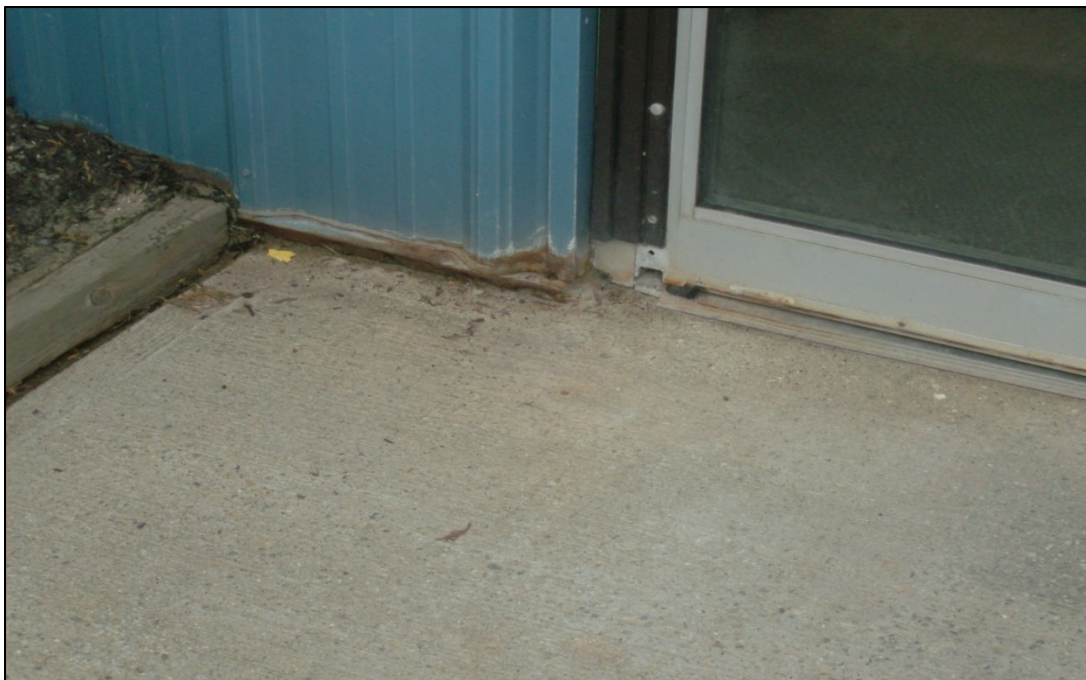
Corrosion at bottom of door and siding at entrance to offices.

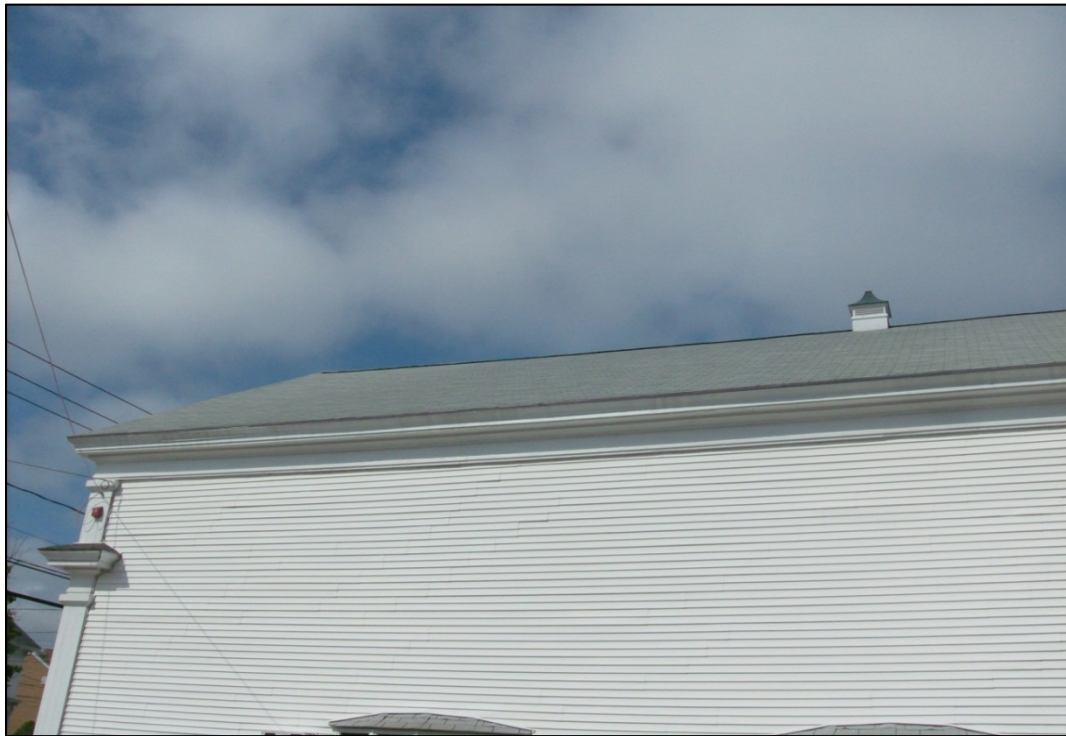
Roof of Senior Center. Shingles in good condition.

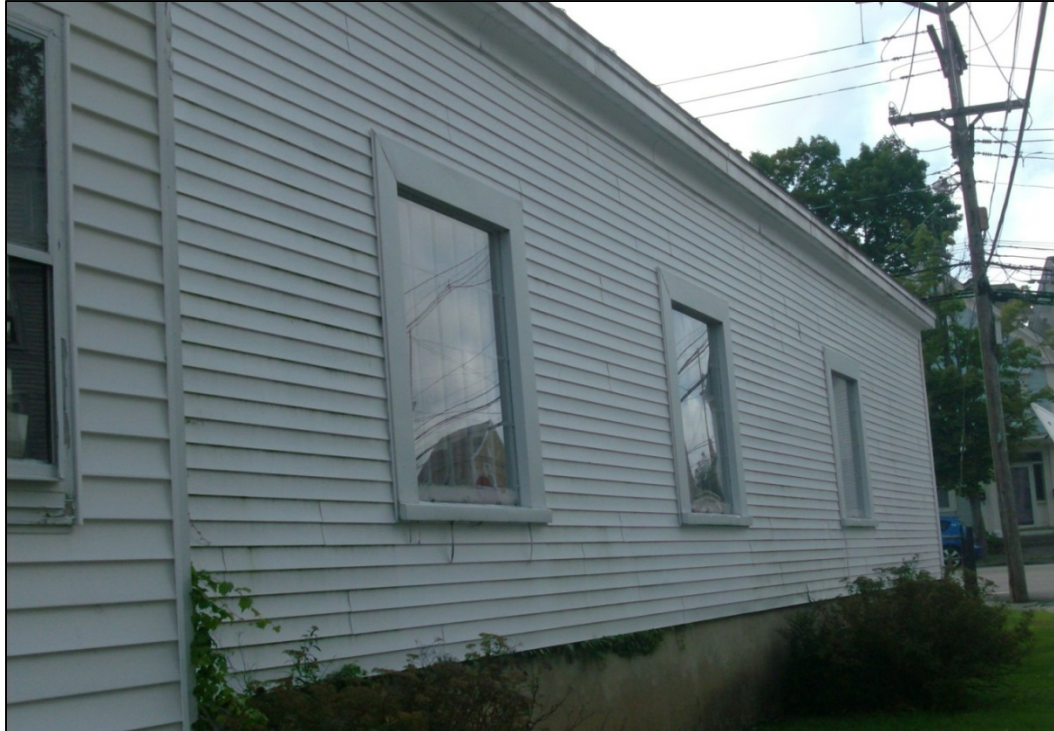
North wall of Fire Museum. Note plexi-glass panels over the original windows.

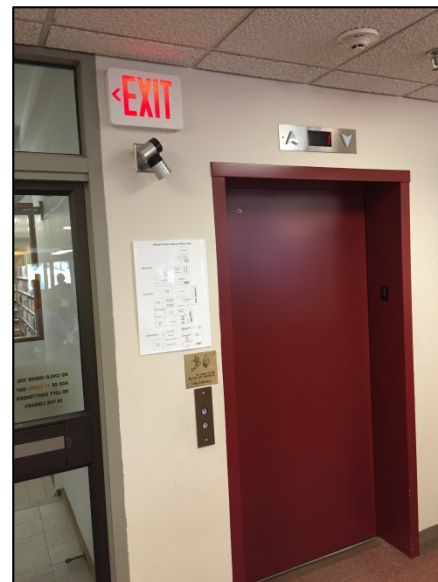
Exit Sign and Remote Battery Unit Heads

There were LED exit signs in good condition and the coverage was adequate throughout.

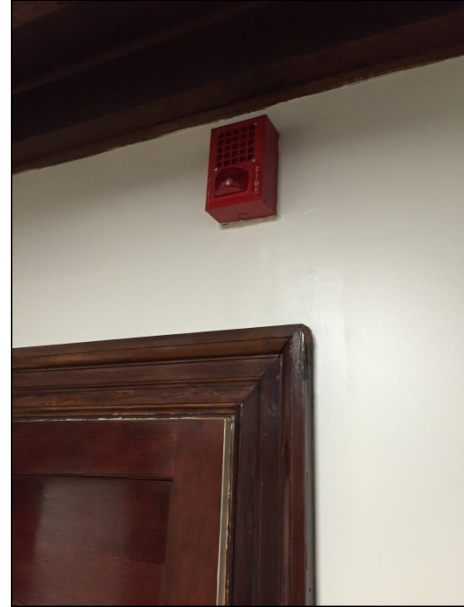
Existing Fire Alarm Audio Visual Device

It is recommended notification devices shall be replaced with new ADA style devices and additional devices added to meet NFPA coverage requirements. Additional smoke detectors shall be provided on 30'-0" centers in corridors and open office areas. Existing pull stations shall be relocated to 48" to meet ADA requirements.

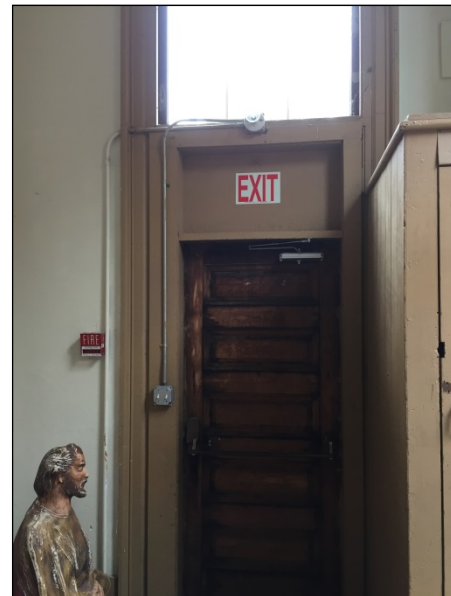
Plastic Non-illuminated Exit Sign

There were iridescent style non-powered exit signs. These signs appear to be new and in good condition. Although these are new and may meet code, 120v wired exit signs with battery back-up shall be installed at all egress doors, corridors and meeting rooms.

- Provide additional fire alarm notification devices and replace older devices with new devices.
- Provide 120V battery backed-up emergency exit signs and emergency battery units throughout to meet all life safety requirements.

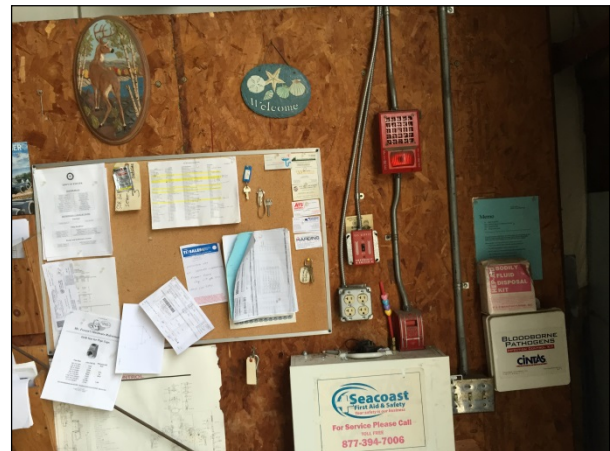
Pull Station with NON-ADA Type
