RE: Water Street and Swazey Parkway Culverts over Norris Brook  
KLF/SEA Reference No.: 2002445.02-A

As a follow up to our 2004 evaluation, Kleinfelder / S E A completed a supplemental structural and project site evaluation on March 28, 2011 for the Water Street and Swazey Parkway Culverts. Our findings and recommendations, which are based on deficiencies identified by visual observations only, are summarized below.

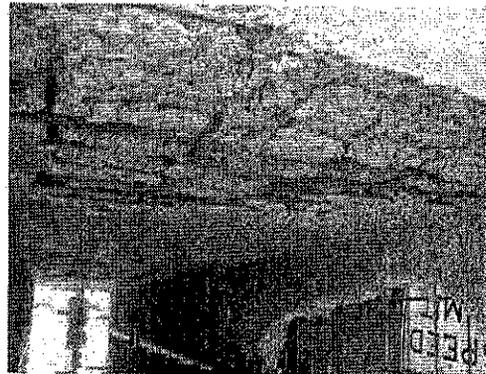
Since our inspection in 2004 the culvert has continued to deteriorate at an accelerated rate. The overall condition has gone from pour to serious. The portion of the underside of the top slab near the inlet that showed signs of significant leakage and deterioration back in 2004 has now completely spalled off and left the bottom mat of slab reinforcing steel exposed.

Bottom of Top Slab -- April 2011

The existing concrete culvert and stone masonry wingwalls are now in serious condition and immediate corrective action is needed. The following short-term recommendations are not long term solutions but they are intended to help prolong the service life of the culvert until the culvert can be replaced with a precast concrete box culvert system as outlined in our April 2004 letter report.

- Reduce traffic over the culvert to one lane by shutting down the upstream lane. Wheel lines for the upstream lane are currently traveling over the most severely deteriorated section of the culvert. The backfill material in this area continues to wash out because large portions of both vertical legs of the culvert are missing on the upstream side. The roadway has been patched but the differential settlement in the roadway surface is resulting in additional vehicle impact loads on the culvert. The steel plates that were added on the top of the slab should remain in place. There are a couple of options for maintaining and protecting traffic that should be evaluated. One potential option is one way alternating traffic over the Water Street culvert using temporary signals. A second option includes allowing one way southbound traffic on the Water Street culvert while using Swazey Parkway to handle one way northbound traffic.

- Cut out portions of rough pavement and repave. The smoother the approaches the less impact loading there is on the structure.
- Continued monitoring of the condition of the structural concrete in the walls and slab. Based on the current condition it is recommended that the culvert be inspected every three months with particular focus on the inlet portion of the culvert. The recommended frequency could change based the results of the subsequent inspections. It is also recommended that the culvert be inspected after any significant storm events or anytime sudden settlements in the backfill are observed.

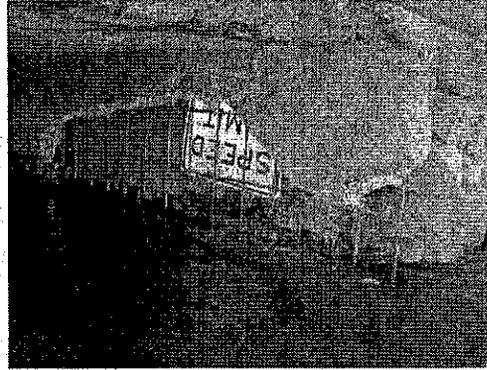
The larger hole with exposed reinforcing steel that was observed in the southern wall of the culvert near the inlet during our original inspection has more than doubled in size since 2004. The hole in the SW corner is now approximately 8 feet in length with a maximum height of approximately 30 inches. A

Deteriorated Southern Wall (Inlet End) – April 2011

- Continue monitoring the paved roadway for settlement, particularly in the sections where there are voids in the walls of the culverts. Roadway settlement indicates that the backfill material is

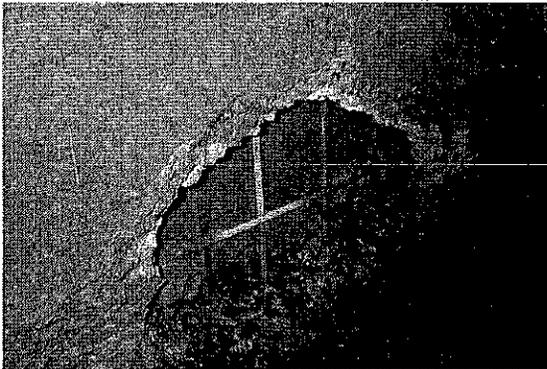
Deteriorated Northern Wall (Inlet End) – April 2004

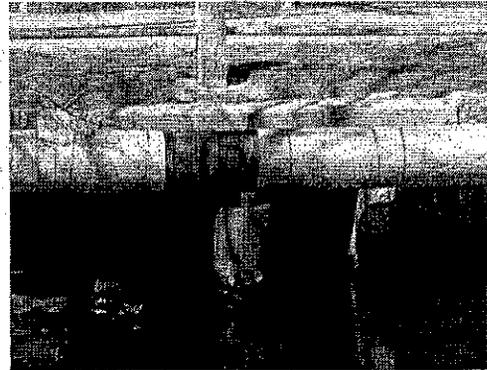
Deteriorated Outlet – April 2011

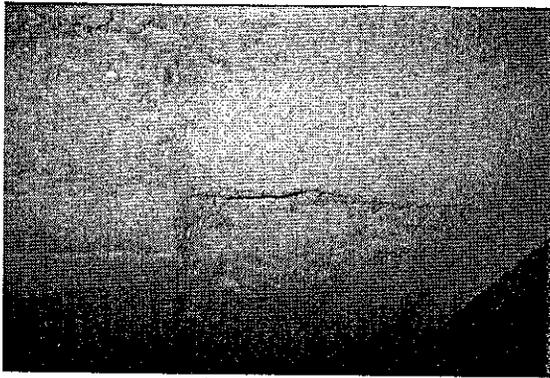
Deteriorated Bottom of Top Slab – April 2004

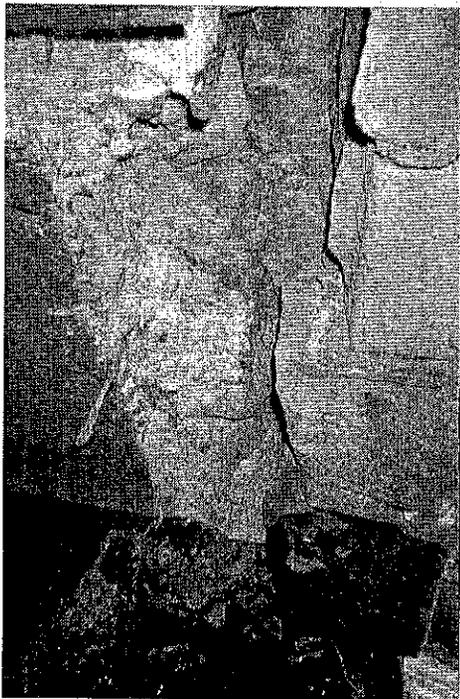
Deteriorated Slab at Upstream Headwall – April 2004

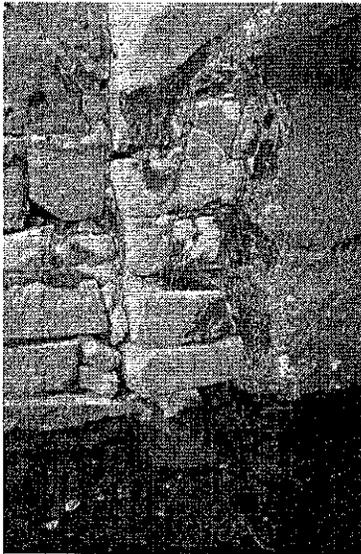
Deteriorated South Wall (Outlet End) – April 2004

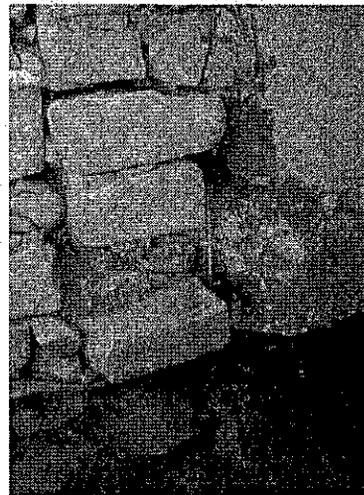
The walls remain severely deteriorated at each corner on the outlet end. The deteriorated upstream corners were recently patched. Increased deterioration with exposed aggregate can be seen along the bottom (near the channel) over the entire culvert length. The stone/concrete interface at the culvert openings is in poor condition at the outlet end of the culvert. Since the concrete has already undergone significant deterioration in these locations, the potential for collapse of the stonework is greatly increased, particularly during the winter months with the exposure to the fluctuating tide and freeze/thaw cycles. This stone/concrete interface was recently patched on the inlet end.

Deteriorated South Wall (Outlet End) – April 2011
