**RE: Corrective Action Report – Area 1
Exeter Sportsman’s Club
Waterworks Pond Road
Exeter, New Hampshire
DES Site #200212050, DES Project #12496**

**Exeter Sportsmans Club
Lead and PAH Remediation
Exeter, New Hampshire**

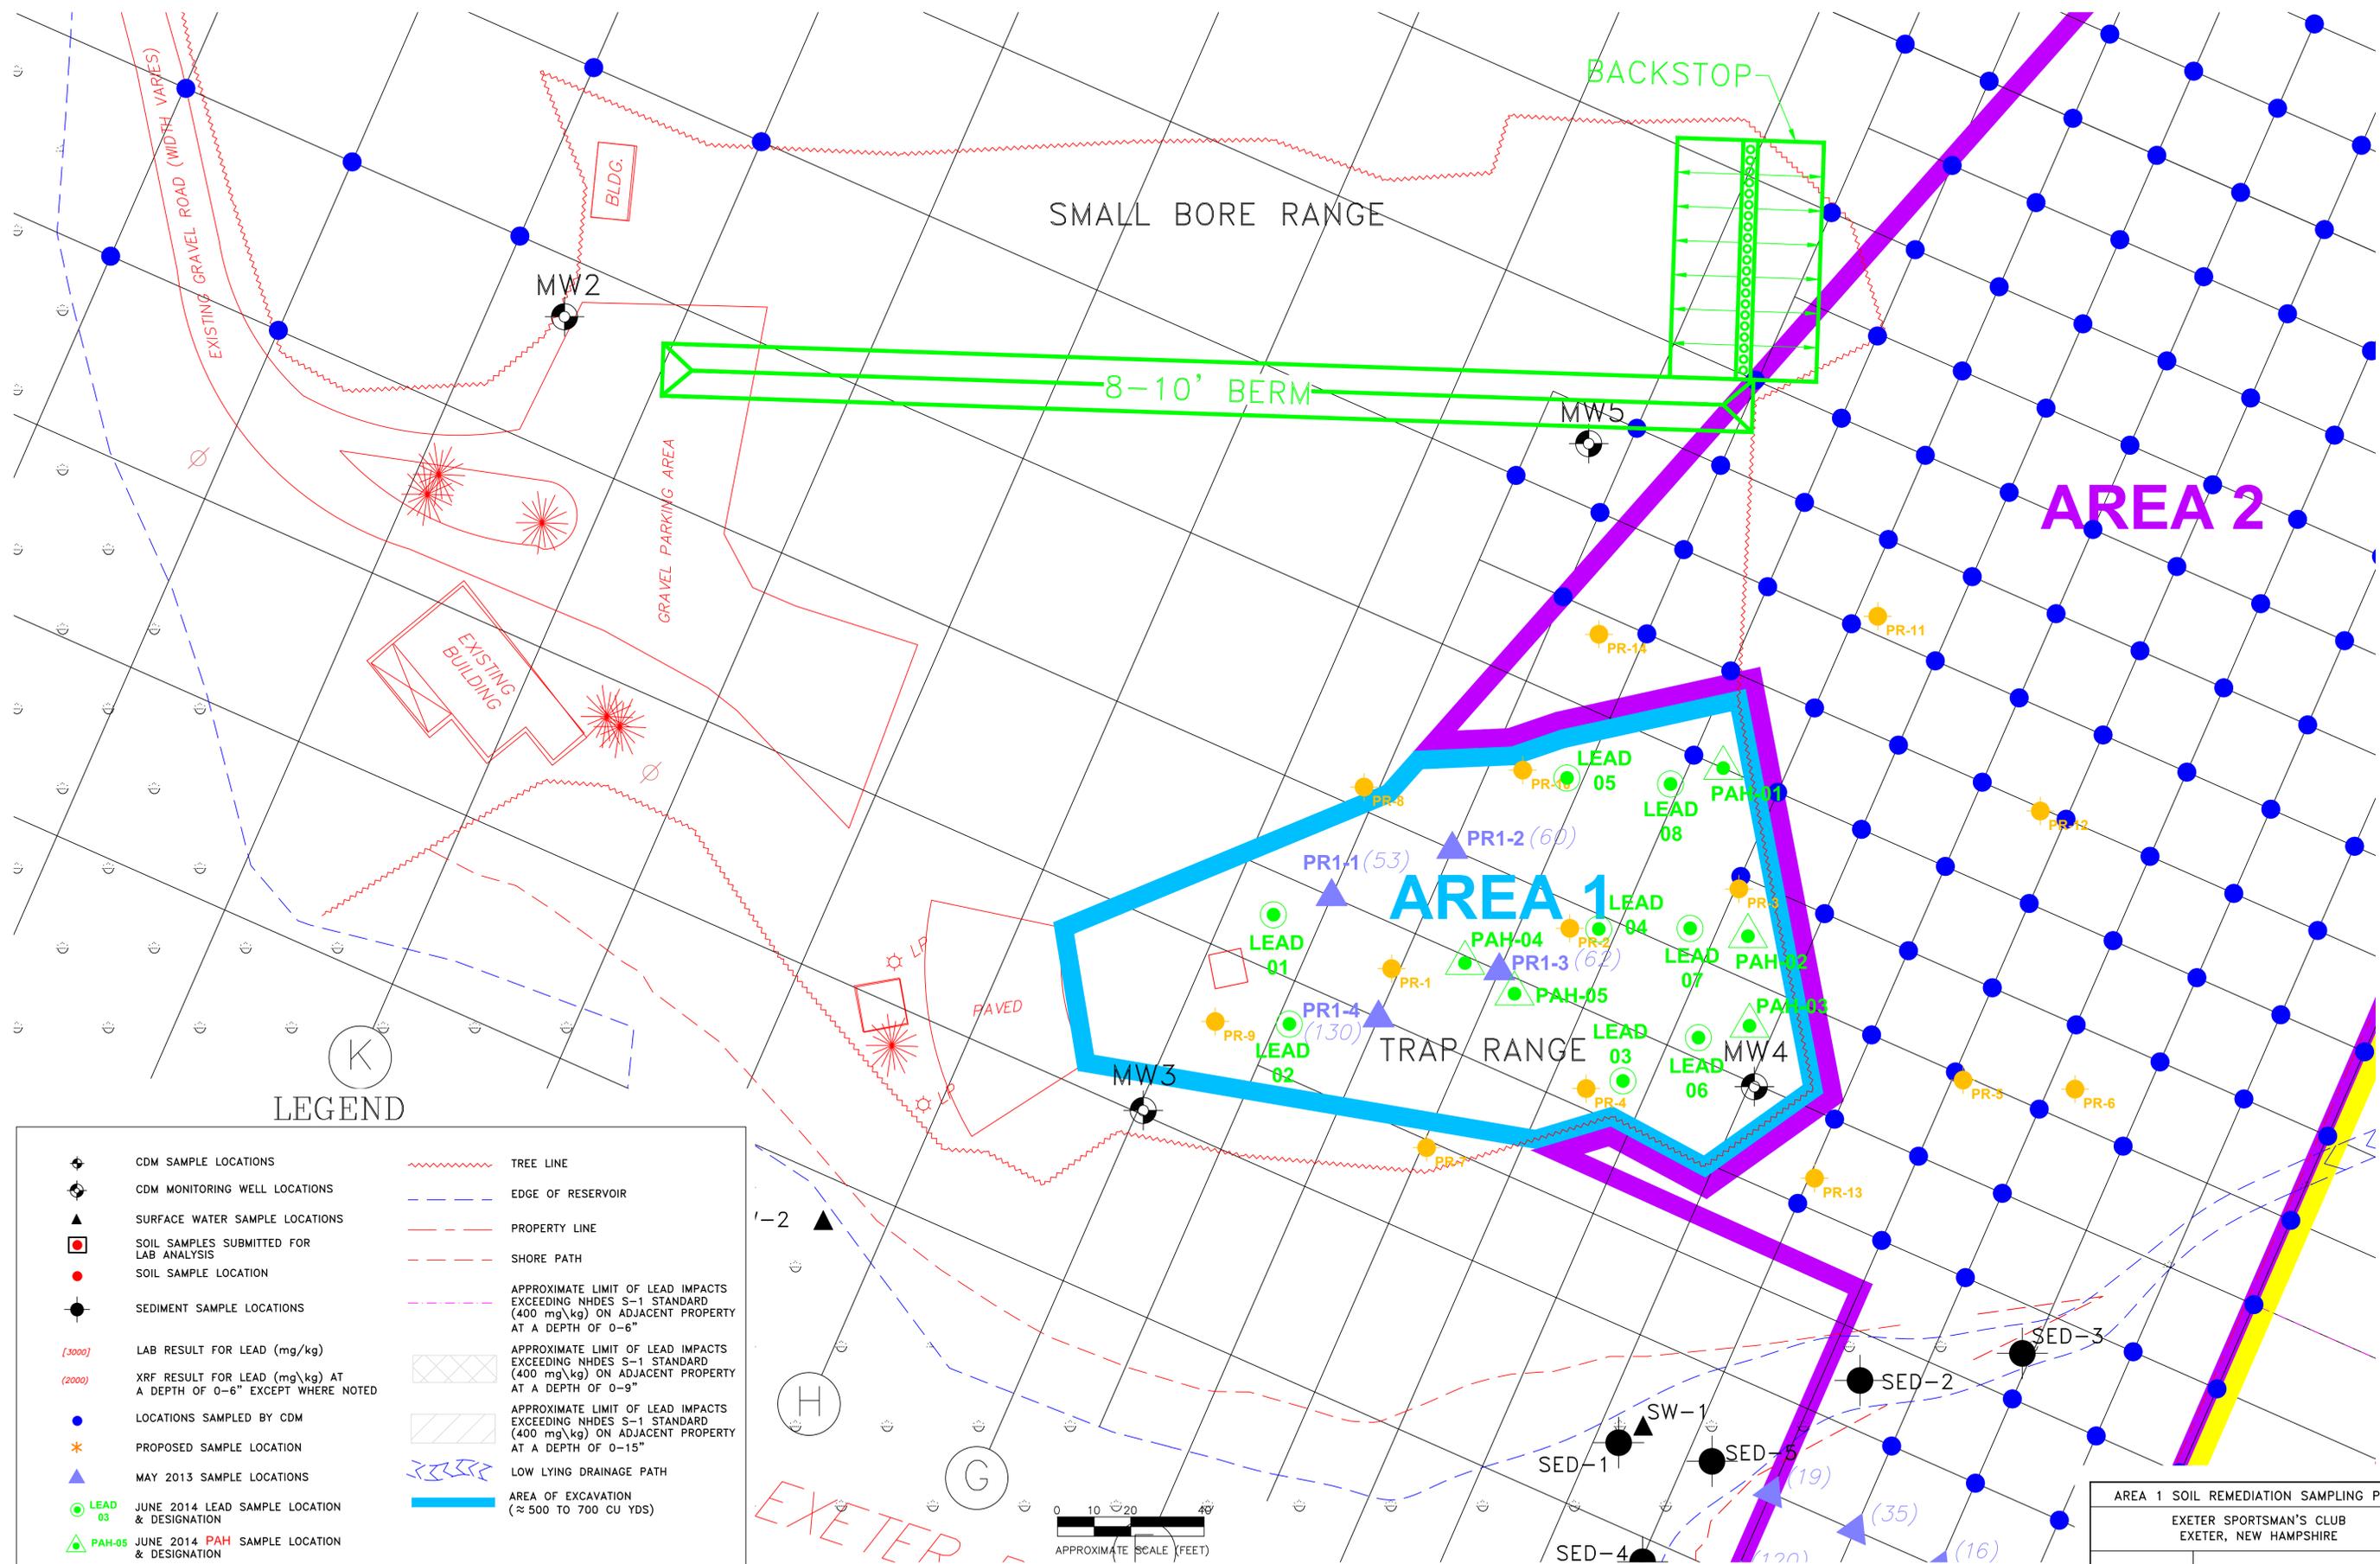
DRAWN BY: HAJ PROJECT NO.: 39743921 FIGURE NO.:
DESIGN BY: TM SCALE: 1" = 20'
APPROVED BY: GNC DATE: 07/14 2

AREA 1 SOIL REMEDIATION SAMPLING PLAN
EXETER SPORTSMAN'S CLUB
EXETER, NEW HAMPSHIRE

On behalf of the Town of Exeter (Town) and in accordance with *Env-Or 606.14 Corrective Action Prior to Remedial Action Plan Approval*, URS Corporation (URS) is submitting this Corrective Action Summary report for the remediation of the open portion of the trap range located at the Exeter Sportsmans Club (ESC) on Waterworks Pond Road in Exeter, New Hampshire. Figure 1 depicts the location of the site on a US Geologic Services Topographic map. Approval of a scope of work that involved the excavation and off-site disposal of a clay target berm, and the excavation and relocation of lead impacted soils into a new berm along the eastern side of the small bore range, was granted by the New Hampshire Department of Environmental services on October 24, 2013. This work was conducted in order to promote timelier remediation of the portion of the site identified as Area 1 in Figure 2.

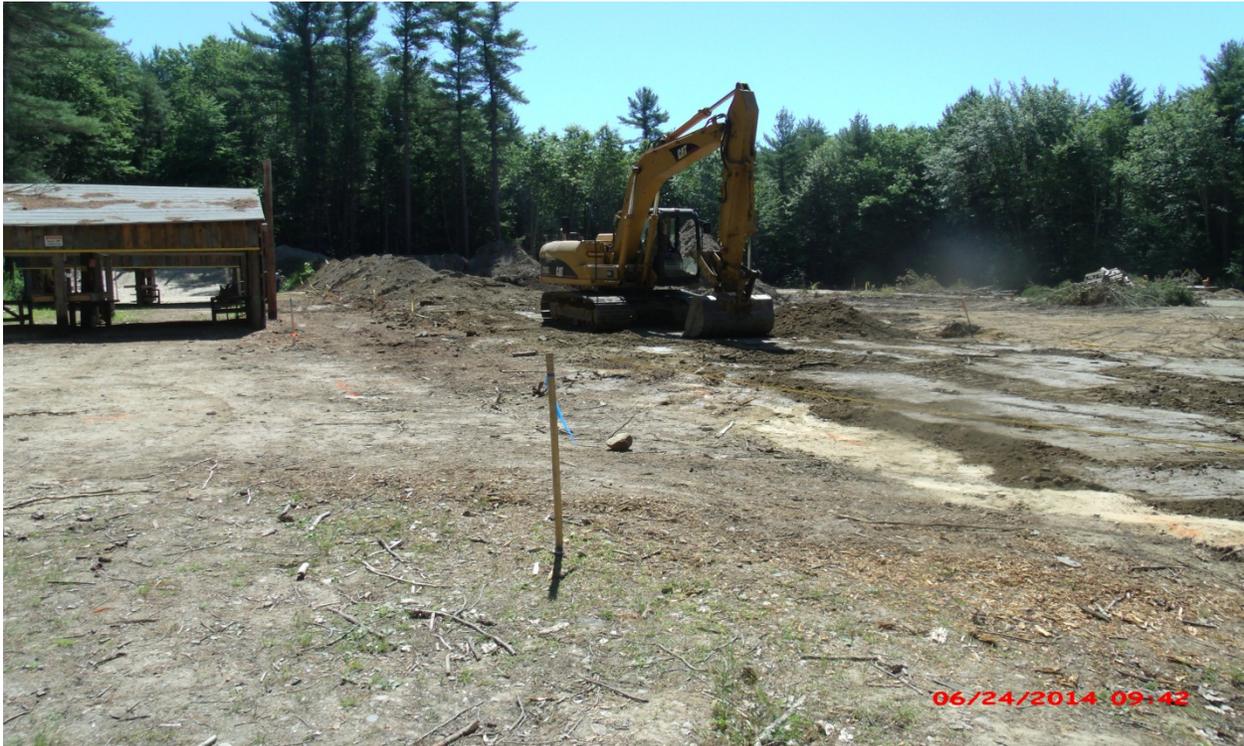
Photograph 1 - Area of tree removal between the small Bore Range and the Former trap Range

On May 9, 2014 the project was initiated under the direction of Mr. Joseph Kenick of the Exeter Sportsmans Club. Work began in the northern and western portions of the former trap range where tree clearing was required. Photograph 1 in Attachment A shows the area where trees were removed between the small bore range and the trap range. This area was clear cut and partially grubbed. Stumps located in the proposed berm alignment remained in place while stumps outside the area were stockpiled and burned to reduce their size. The imported fill that was previously stored on the trap range was relocated to cover the stumps that were left in place in the area where the small bore range berm was to be constructed. Trees along the northern end of the trap range were also cut and grubbed to provide access to the clay target berm (See Photograph 2). Approximately 240 cubic yards of clay targets and soil were removed and disposed of at the Raymond Transfer Station in Raymond, New Hampshire.

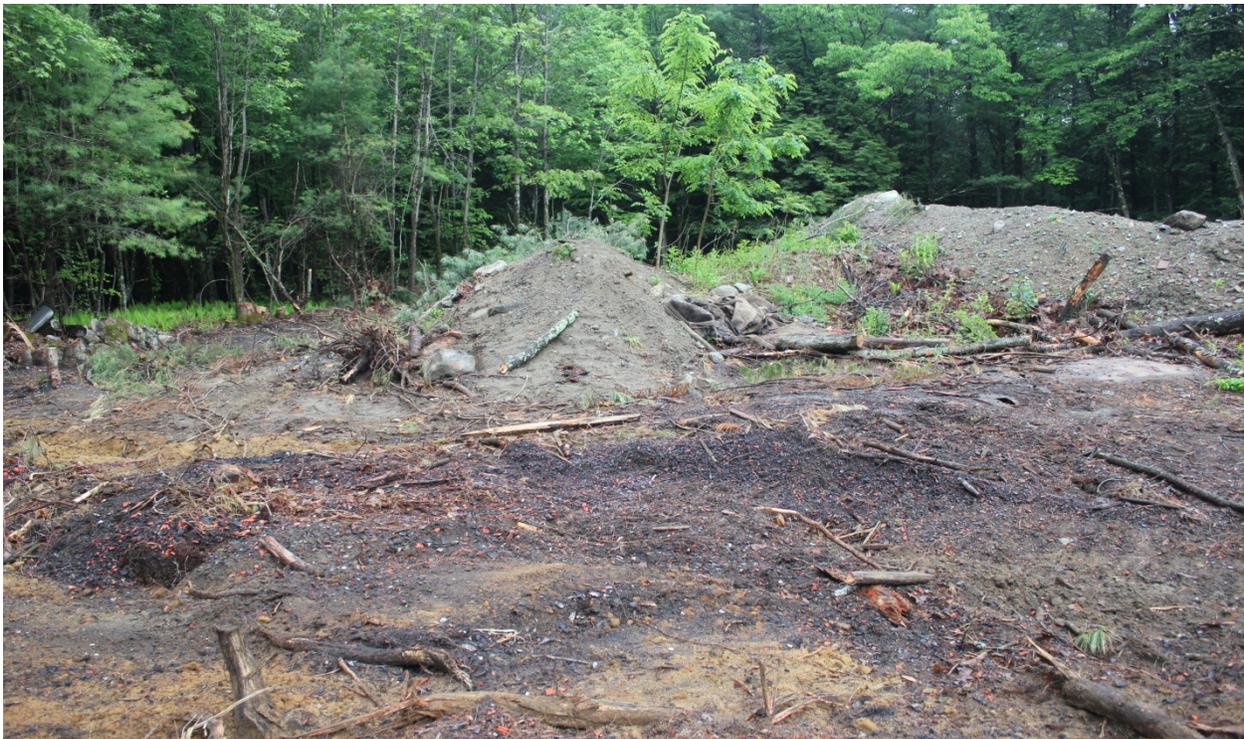
Photograph 2 - Area of clay target berm to be loaded and shipped for off-site disposal

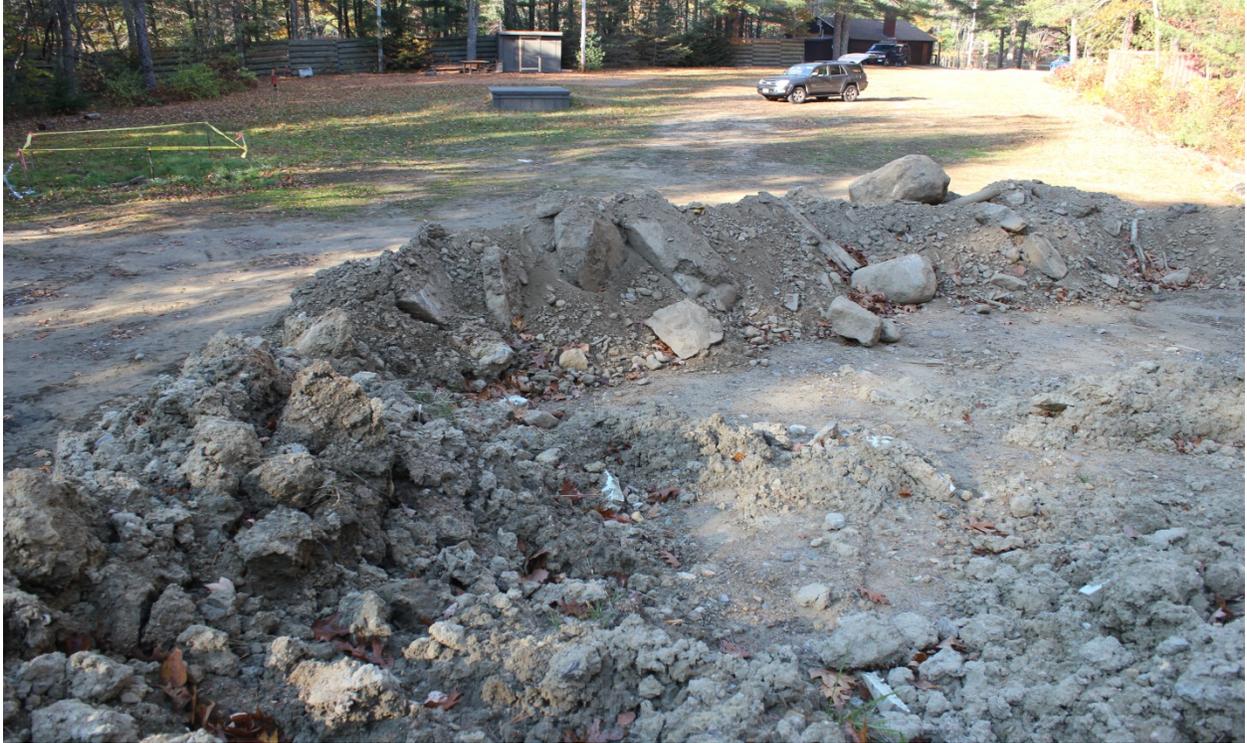
Photograph 3 - Area of PAH removal surrounding sample location PR1-3 delineated with caution tape

On June 16, 2014, URS staked out the limits of the soil excavation. The layout was initiated by identifying the area around sampling location PR1-3 that required 24 inches of poly aromatic hydrocarbon (PAH) impacted soil to be removed (See Photograph 3). This area is where CDM had previously excavated a shallow test pit and had mixed clay target fragments with soils up to 15 inches deep. March 2013 analytical results indicated exceedances of NHDES RCMP S-1 Soil Standards in an approximate 10 foot by 10 foot area. While on site, URS also defined (staked out) the limits of the former trap range requiring 15 inches of lead impacted soil excavation (Photograph 4).

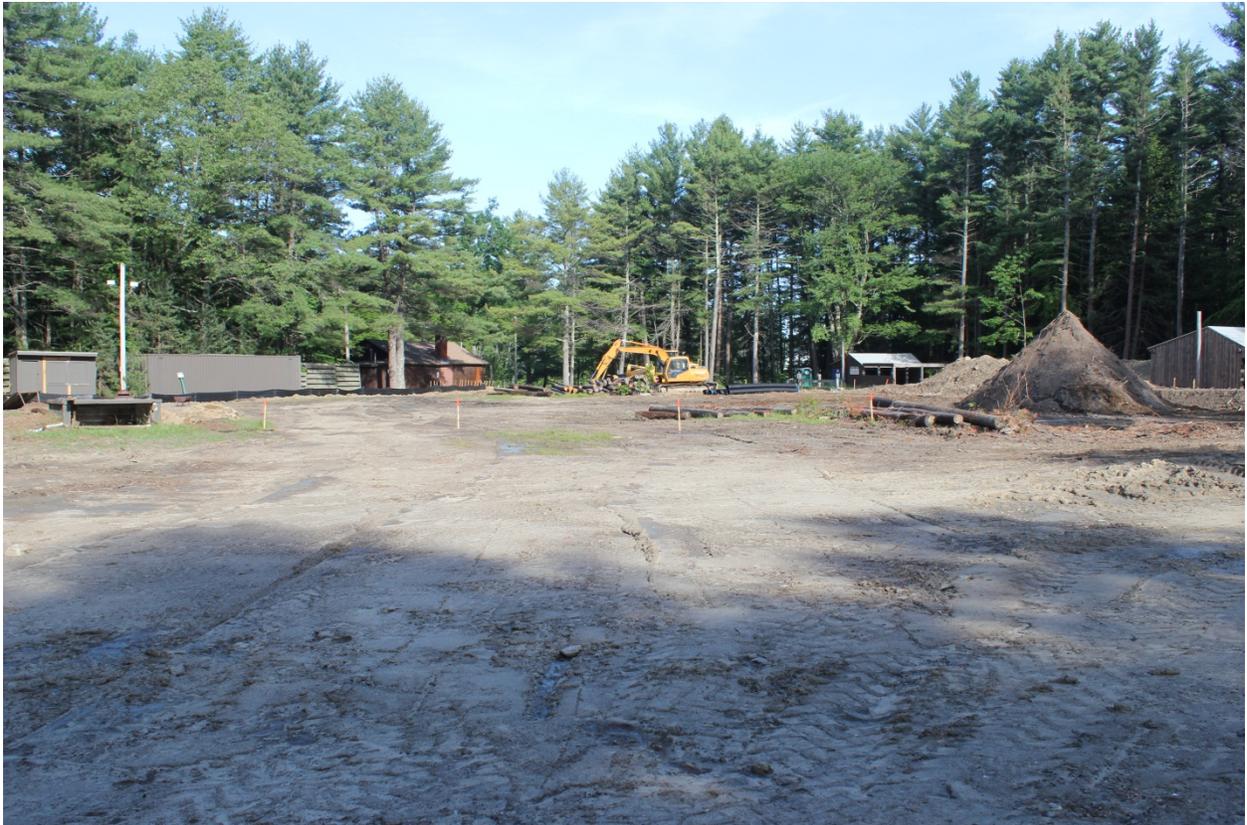
Photograph 4 - Area of the trap range designated for 15 inches of soil removal

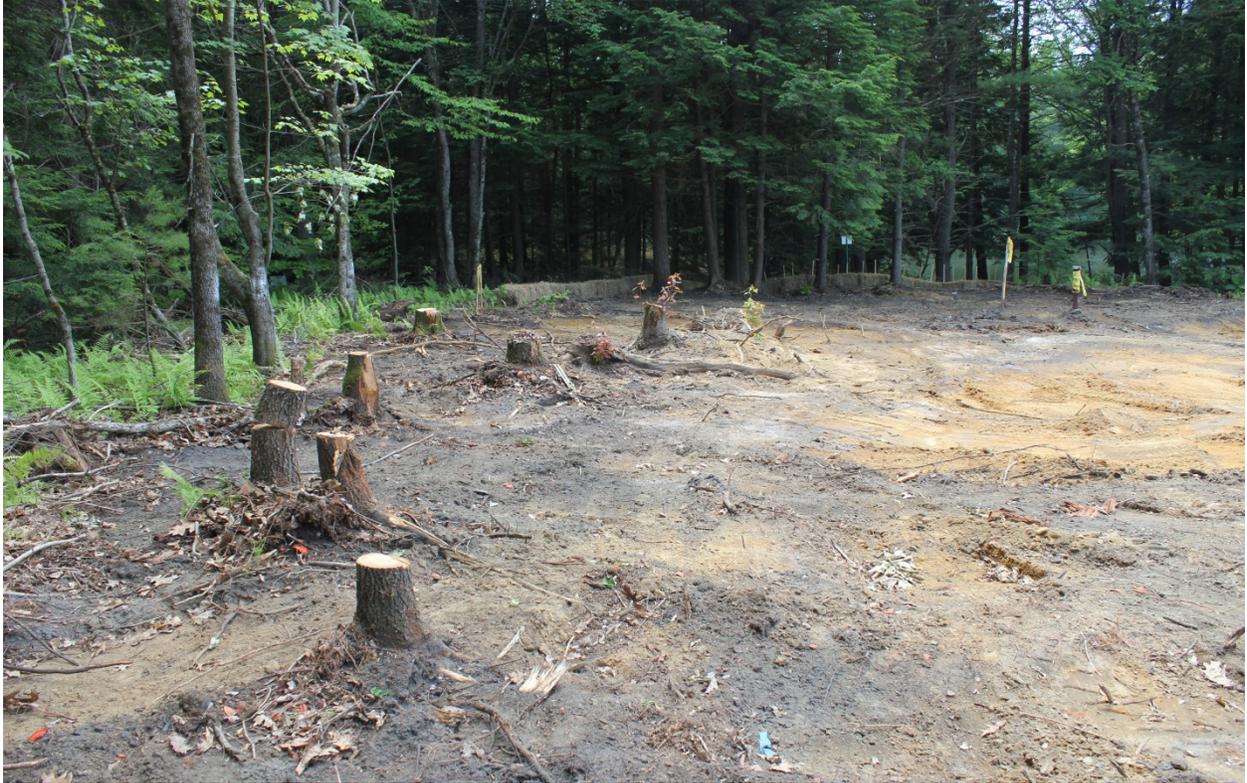
Photograph 5 - Area of former clay target berm

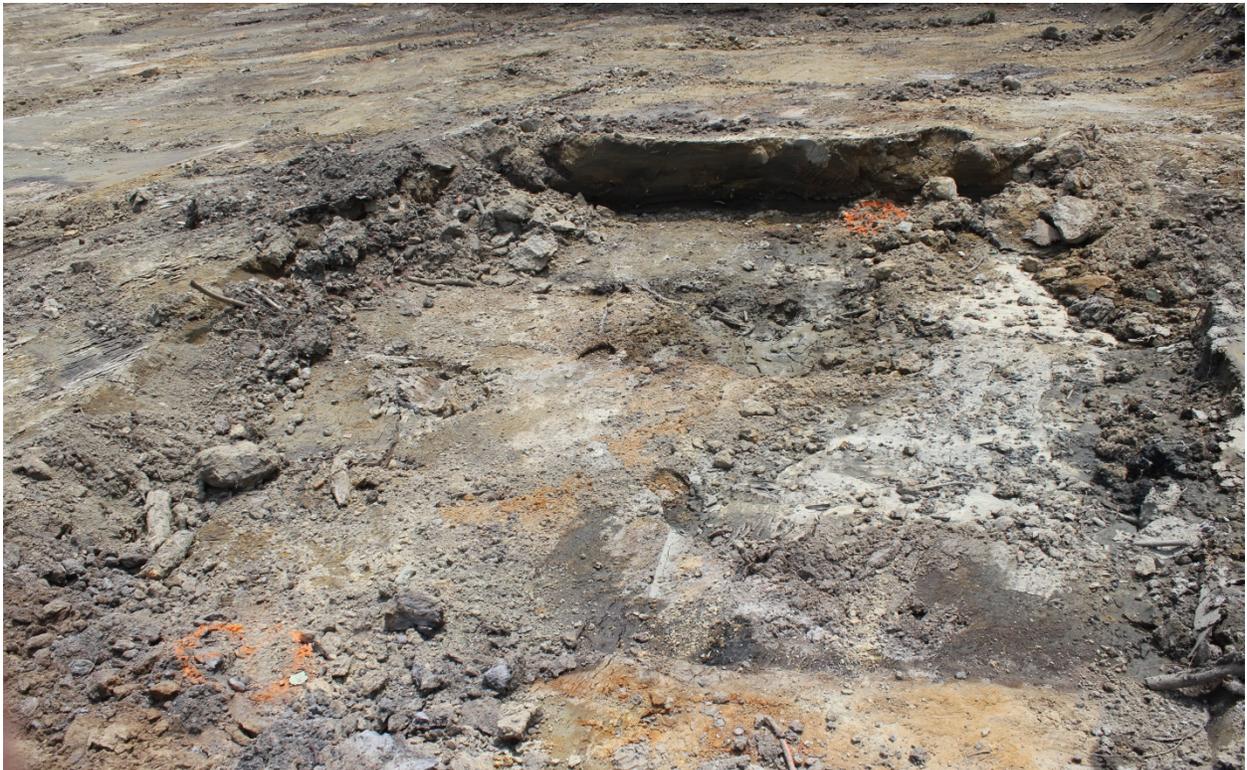
Photograph 6 - Area of PAH impacted soil removal to 24 inches
(Orange circles indicate sample locations)

On the morning of June 20, 2014, excavation began with K.G. Blood and Sons Excavating removing the soil from the vicinity of PR1-3 and along the back of the range where the clay target berm was located. Upon completion of the excavation of 15 and 24 inches of soil, respectively, a total of 5 samples were collected and submitted to Eastern Analytical Incorporated (EAI) of Concord, New Hampshire for PAH analysis using USEPA method 8270. The first three samples designated PAH-1, PAH-2, and PAH-3 were collected from the former clay target berm area (See Photograph 5) while the remaining two soil samples designated PAH-4 and PAH-5 were collected from the 24 inch deep excavation (see Photograph 6). Figure 2 depicts these sample locations. Results of these analyses are summarized in Table 1 and indicated that PAHs were not detected above the laboratory detection limits which were set below the NHDES Risk Characterization and Management Policy (RCMP) Method 1 Soil Standards. Copies of the laboratory analytical reports prepared by EAI are included as Attachment B.

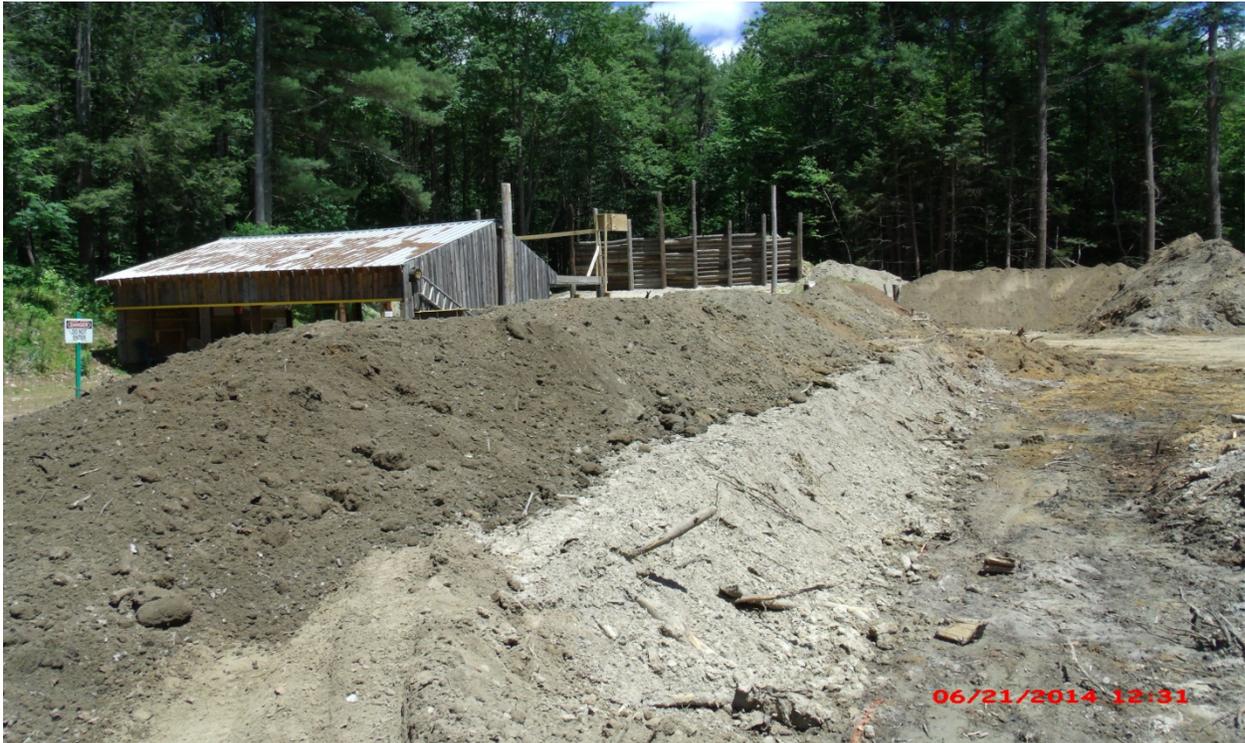
Photograph 7 - Impacted soils placed in small bore range berm

Soil excavation continued in the open trap range portion of the site where 15 inches of lead impacted soil was removed and placed in the small bore range's eastern berm (See Photograph 7). Prior to excavation of this area, ground surface elevations were measured. Excavation was conducted in quadrants with the bottom elevations being surveyed to confirm a minimum of 15 inches of soil had been removed. Photograph 8 of Attachment A shows the area after soil excavation. The orange dots shown in the photo indicate locations of spot elevations. Upon completion of the soil removal, a total of 8 soil samples were collected and submitted to EAI for lead analysis. Results of the analyses are summarized in Table 2 and indicated that concentrations of residual lead in soil ranged from 2.6 to 110 milligrams/kilograms or parts per million (PPM) which is significantly below the NHDES RCMP S-1 Soil Standard of 400 PPM.

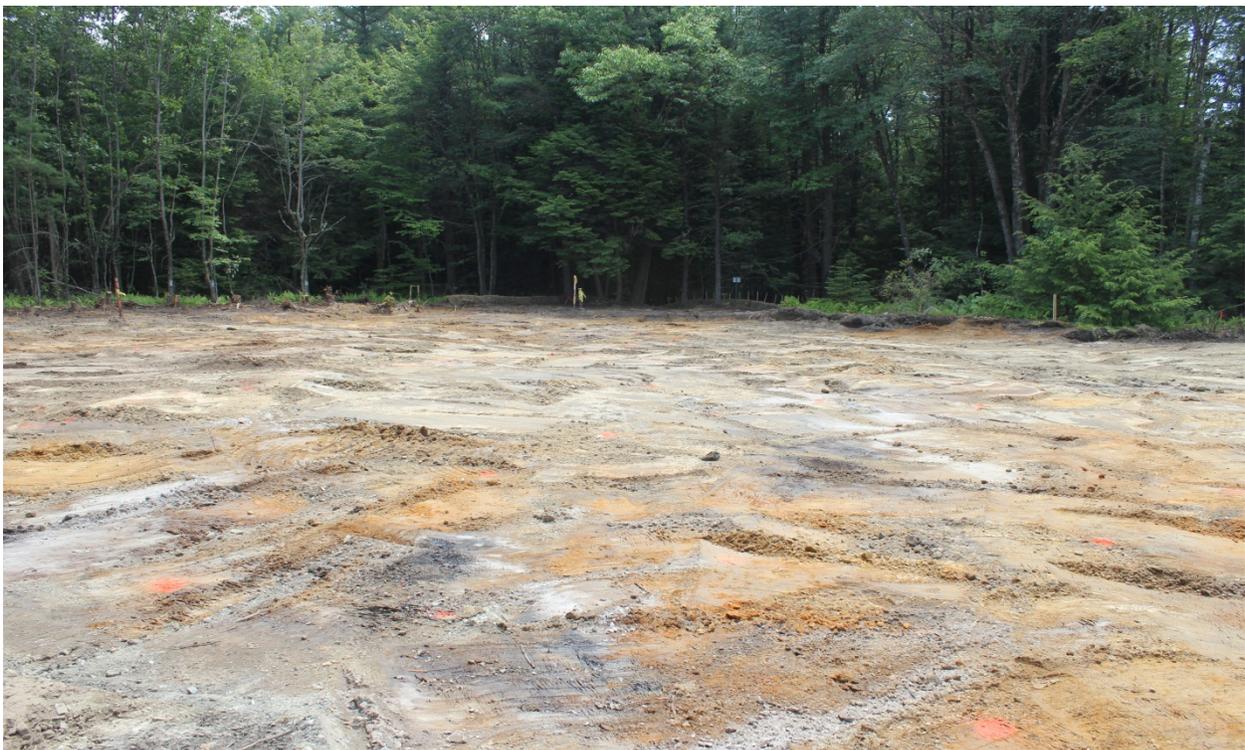
Photograph 8 - Area of the former trap range with 15 inches of soil removed. Orange dots indicate elevation measurement locations

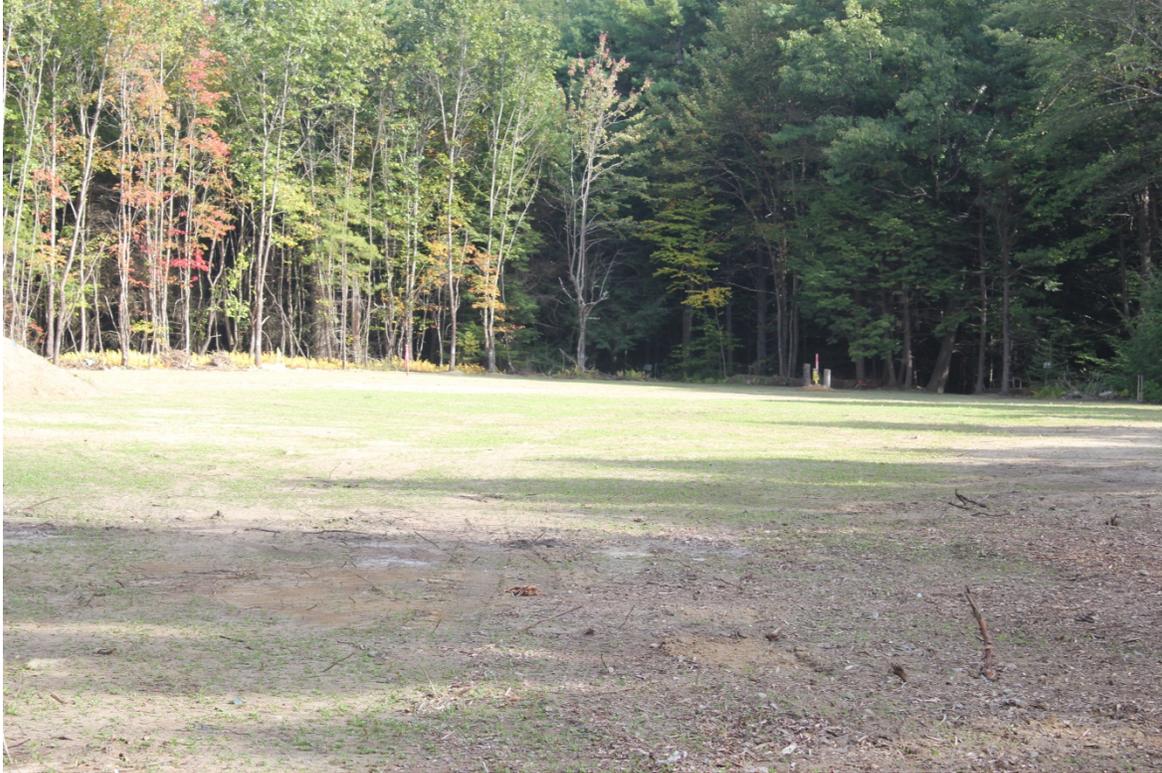
Photograph 9 – Former Trap Range Restored

Sometime between the end of August to the beginning of September 2014, the areas where excavation had occurred were backfilled to re-establish the base grade. Approximately 3 inches of loam was spread over the area and the area was seeded. In addition, the eastern berm of the small bore range was loamed and seeded to establish a vegetative support layer and to limit the potential for erosion of the berm.

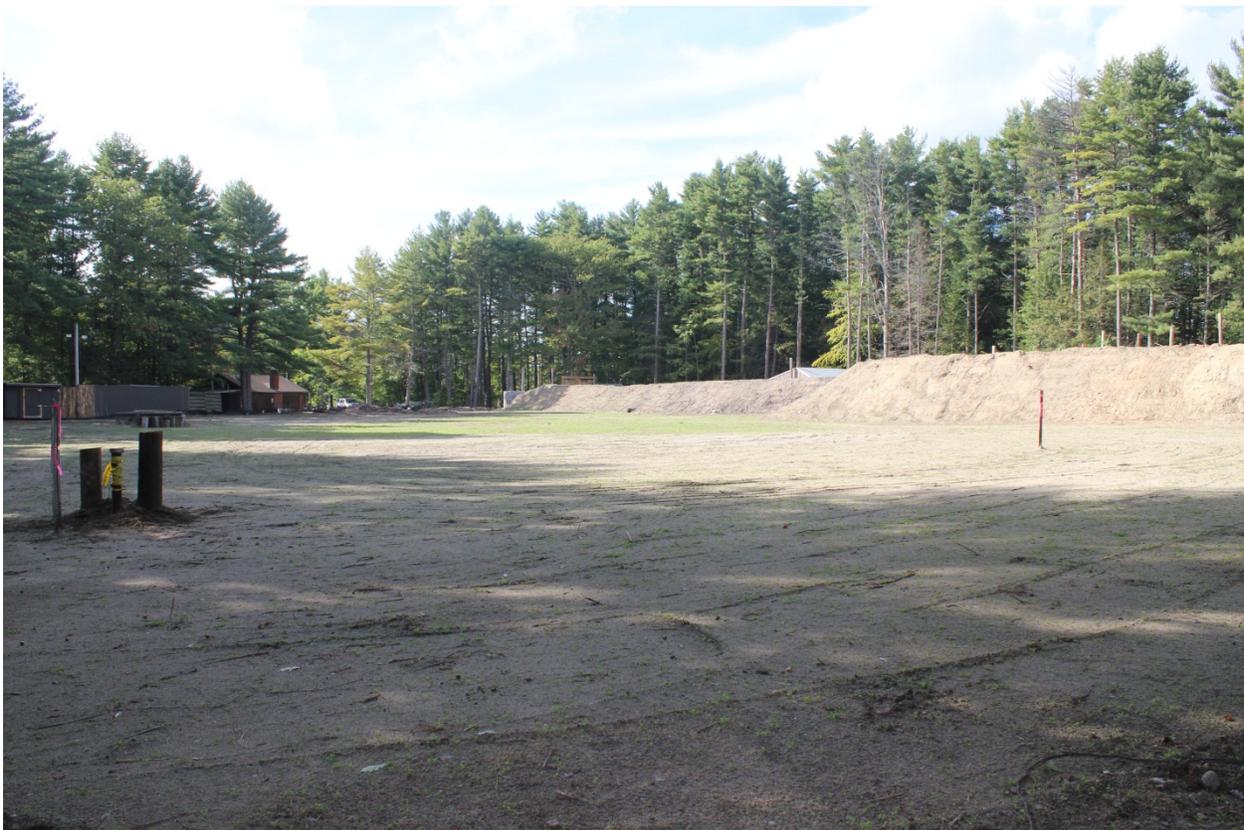
Photograph 10 – Berm containing lead impacted soils covered with loam and seeded
