## Exeter Multigenerational Community Center

10 Hampton Rd, Exeter, NH

### Level II Energy Audit

June 30, 2023

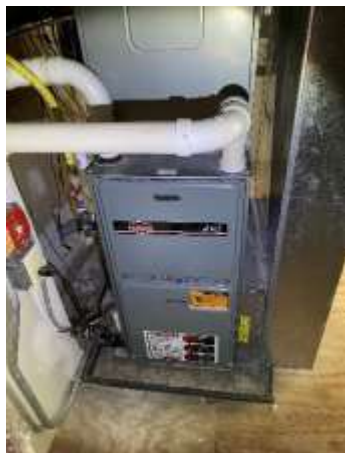
Figure 2: Existing Furnace

**Heating Equipment:** The original section of the building is heated with a 400,000 Btuh, natural gas-fired, one-pipe, steam boiler that has a rated thermal efficiency of 81% AFUE. The heat is supplemented by electric baseboard heat in the first-floor bathroom and two, 1-ton air source heat pumps with a rated SEER of 23. The rear addition is heated by two, 90,000 Btuh, natural gas-fired, sealed combustion furnaces each with a rated thermal efficiency of 92% AFUE.

**M1. Air Source Heat Pumps (ASHP).** The building already has a ducted air conditioning system and furnace, which could be perfect for an ASHP installation. Remove the air conditioning system and furnace and replace it with multiple ducted heat pumps that can utilize the existing ductwork for both heating and cooling. In areas that can't be met with the existing ductwork, install ductless heads.

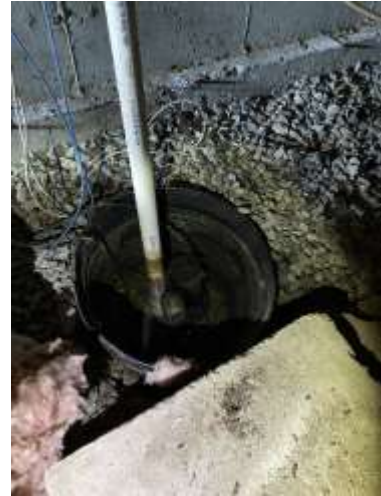
Figure 3: Existing Sump Pump

**Basement moisture:** Both the original basement and the rear addition crawlspace experience high moisture levels due to groundwater intrusion. Although the existing sump pumps can remove bulk water, the basement floor does not provide an adequate air and moisture barrier.

To remedy this issue, install a poly-vapor barrier across the basement and crawlspace floors to equip this area with a moisture barrier. Furthermore, install a dehumidifier if the area experiences high humidity levels after the poly vapor barrier is installed.

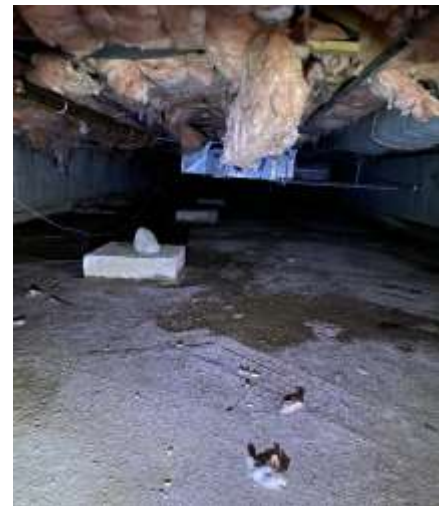
Figure 4: Failing FGB Insulation

**Basement Insulation.** The basement insulation is not adequately fastened to the ceiling. Many portions of the ceiling are missing insulation entirely. Fiberglass Insulation Batts (FGBs) are falling in sections, which means that there is no thermal barrier for parts of the building envelope. Furthermore, there is no vapor barrier, which means that high moisture loads could result in condensation and water damage.

**B4. Basement Insulation:** As discussed in the Notable Issues section of this report, the ceiling of the basement and crawlspace are currently insulated with fiberglass insulation that has not been adequately installed.

To improve this assembly, install a 20-mil vapor barrier from the top of the foundation walls down across the basement floor. After, tape all seams of the vapor barrier to ensure that it is continuous. This will control moisture intrusion into space and reduce humidity levels. Next, install 3” of closed-cell spray foam from the rim joist down to the bottom of the foundation walls. This will provide a thermal resistance of R-21 and significantly reduce the amount of air leakage through the building.

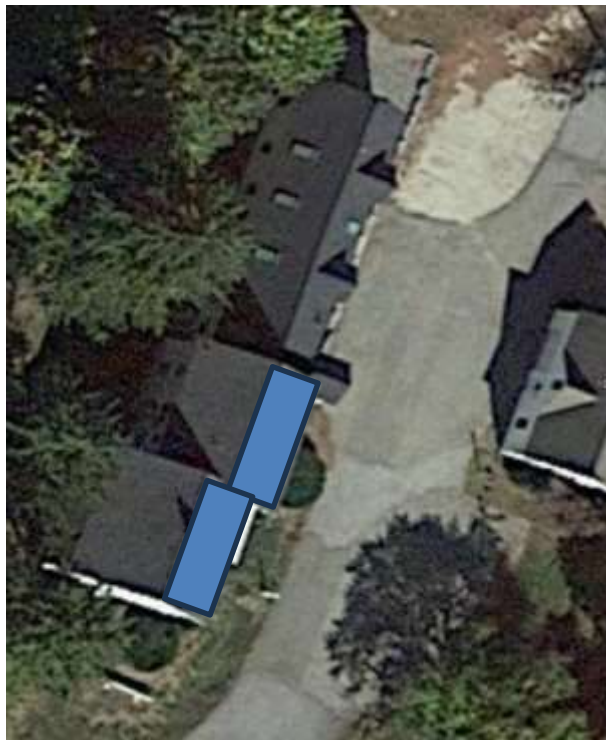
Figure 6: Proposed PV System

**R1. Solar PV:** Solar PV is an excellent way to reduce the building's energy expenses, as well as its carbon footprint. RBG recommends installing a 9 kW roof-mounted solar array on the east-facing portions of the building's roof. The proposed 9 kW array is expected to generate 10,111 kWh of electricity per year, which is 50% of the building's predicted electric load.

If an Air Sourced Heat Pump System is installed to cover the building's heating and cooling needs, then the building's estimated electric usage is 44,497 kWh per year. This means that the proposed solar system could cover up to 22% of the building's total annual electric usage.
