FINAL TOWN WIDE FACILITIES PLAN

TOWN OF EXETER

SPACE NEEDS AND BUILDING ASSESSMENTS

EXETER, NEW HAMPSHIRE

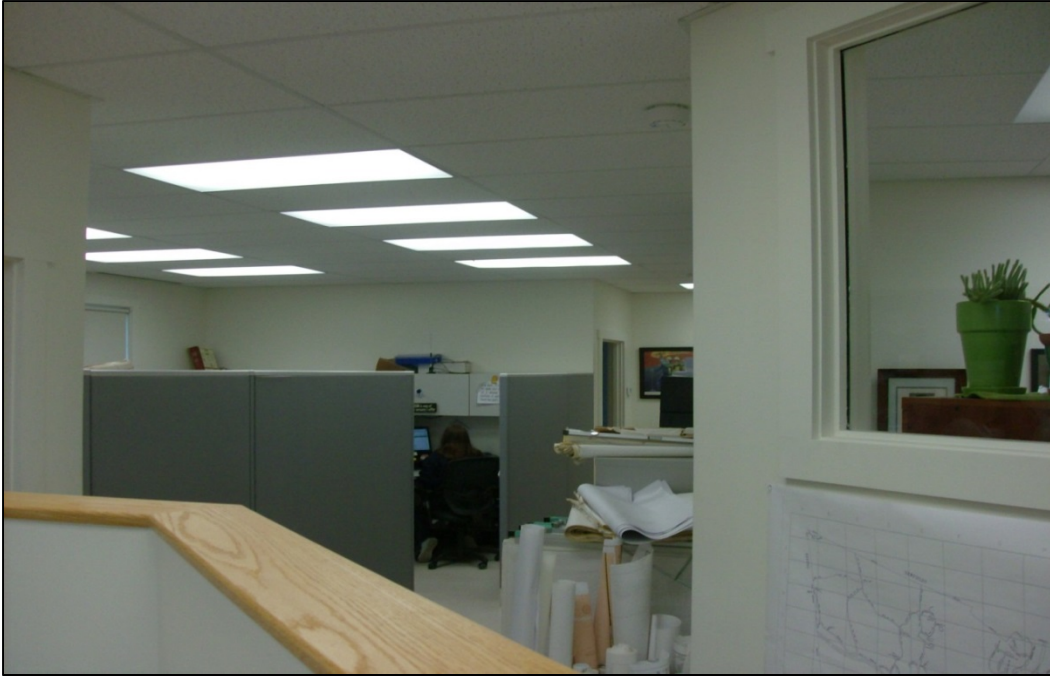
Office overview. Note plan sets on racks and rolled in vertical storage rack.

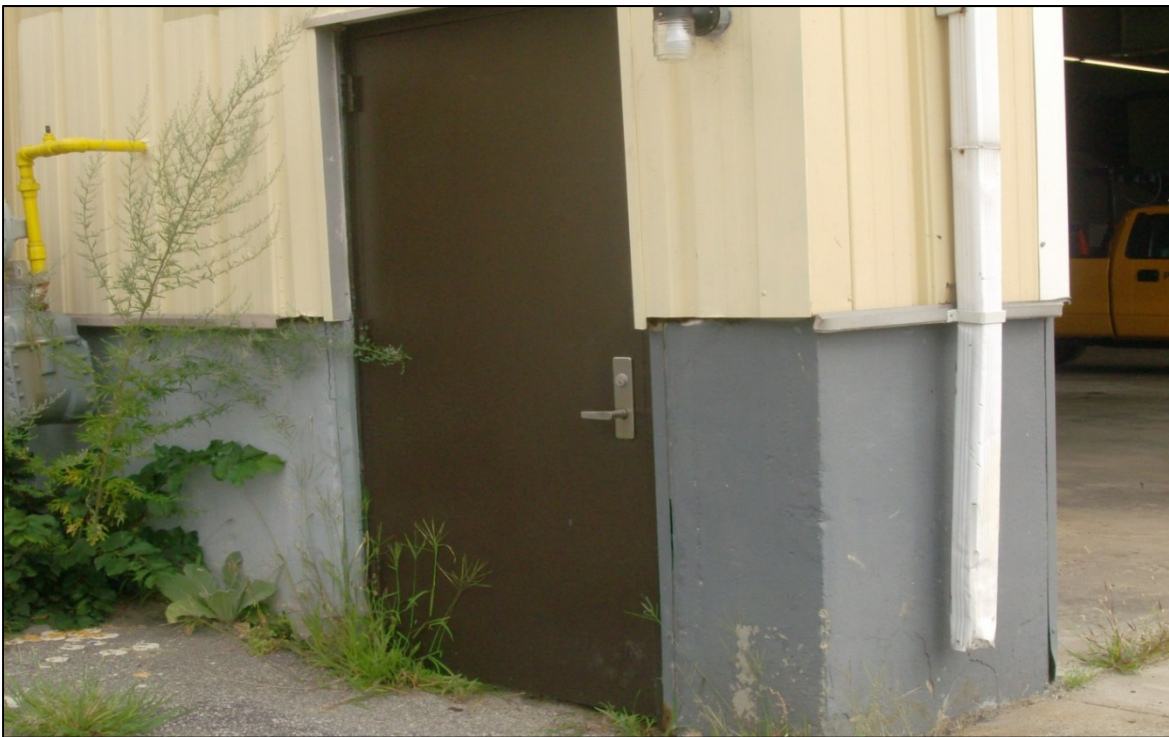
Little used pass door at west side of building.

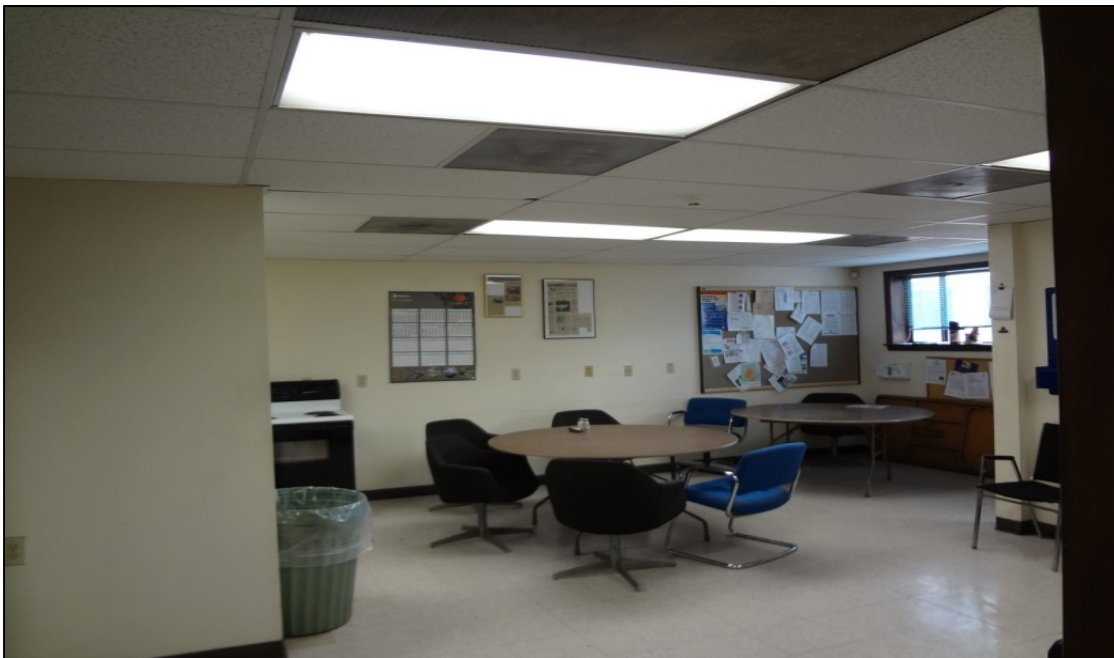
Break room. Note stove with no vent hood.

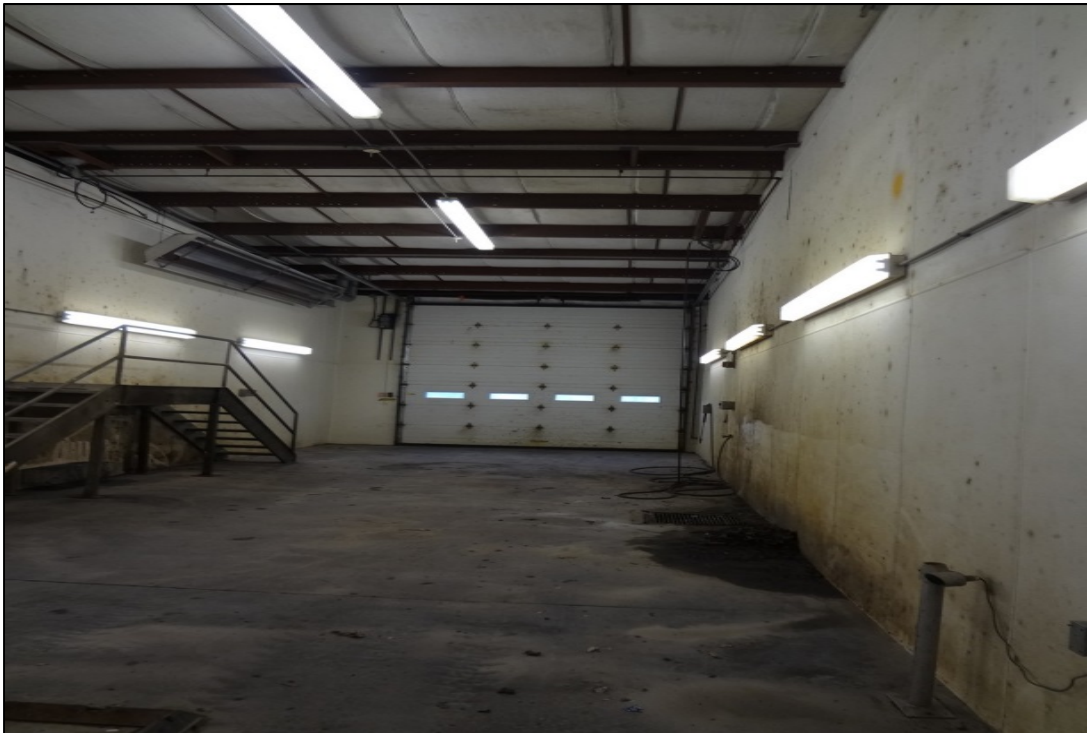
Wash-bay on east side of Water Department Garage. Note Infrared heating units on the wall.

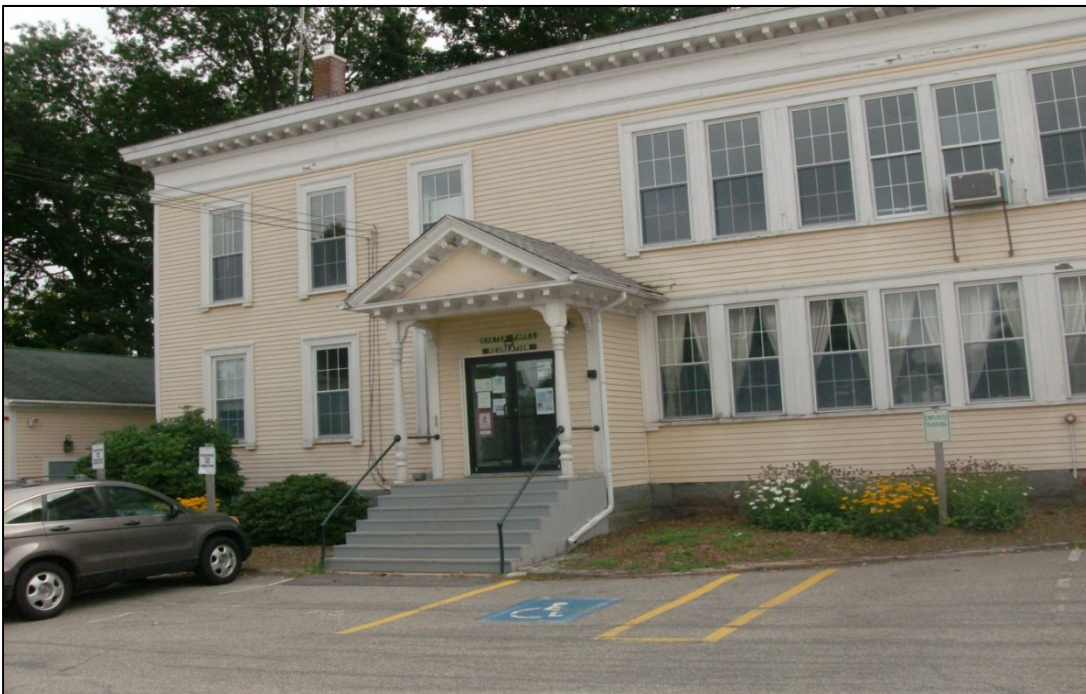
Main entrance from parking lot. Note handicap parking, but entrance is not accessible.

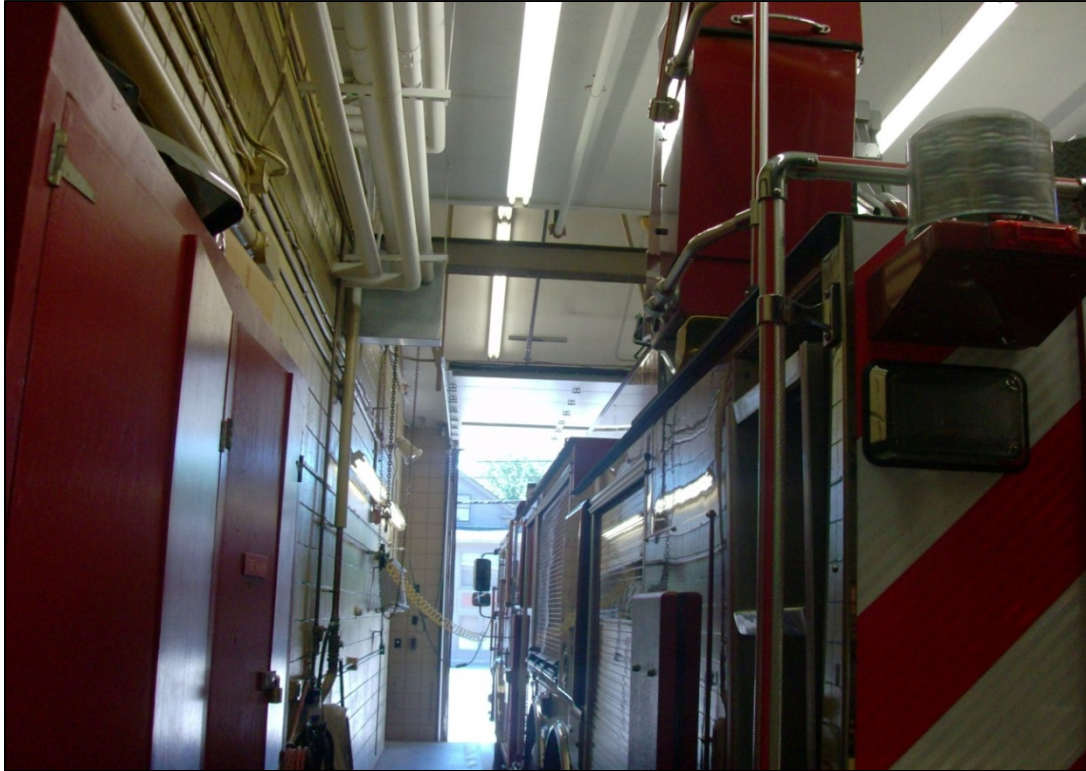
Apparatus bay for Engine 1. Note the lack of clearance.

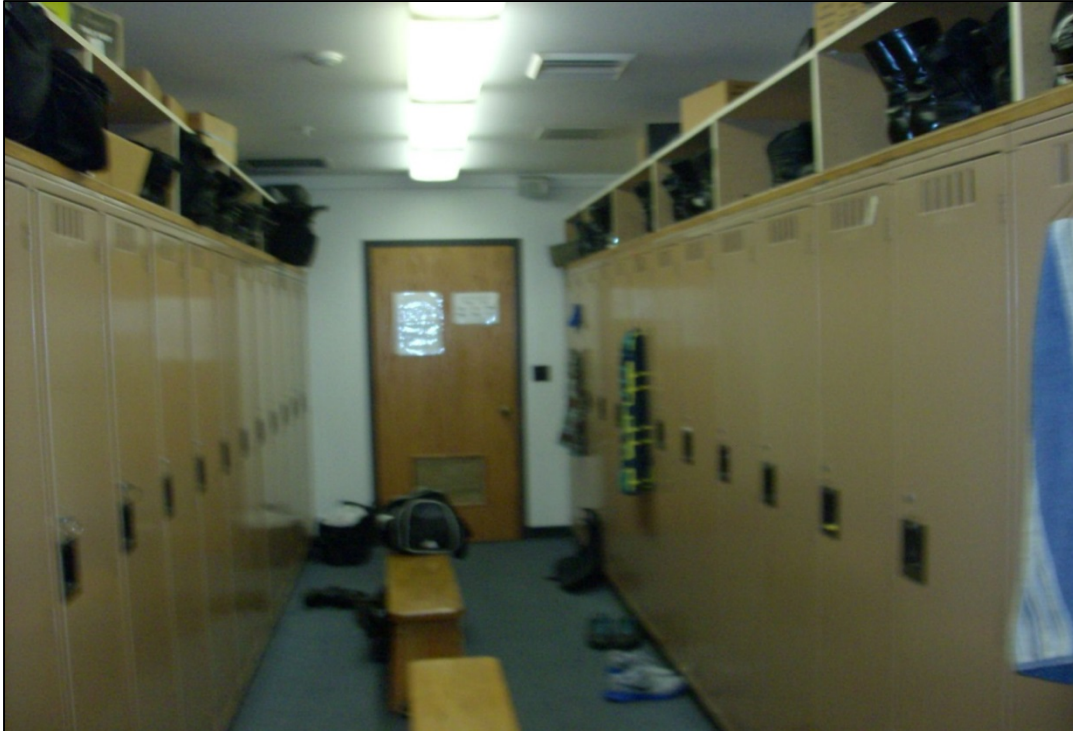
Cramped locker room for the Police Department.

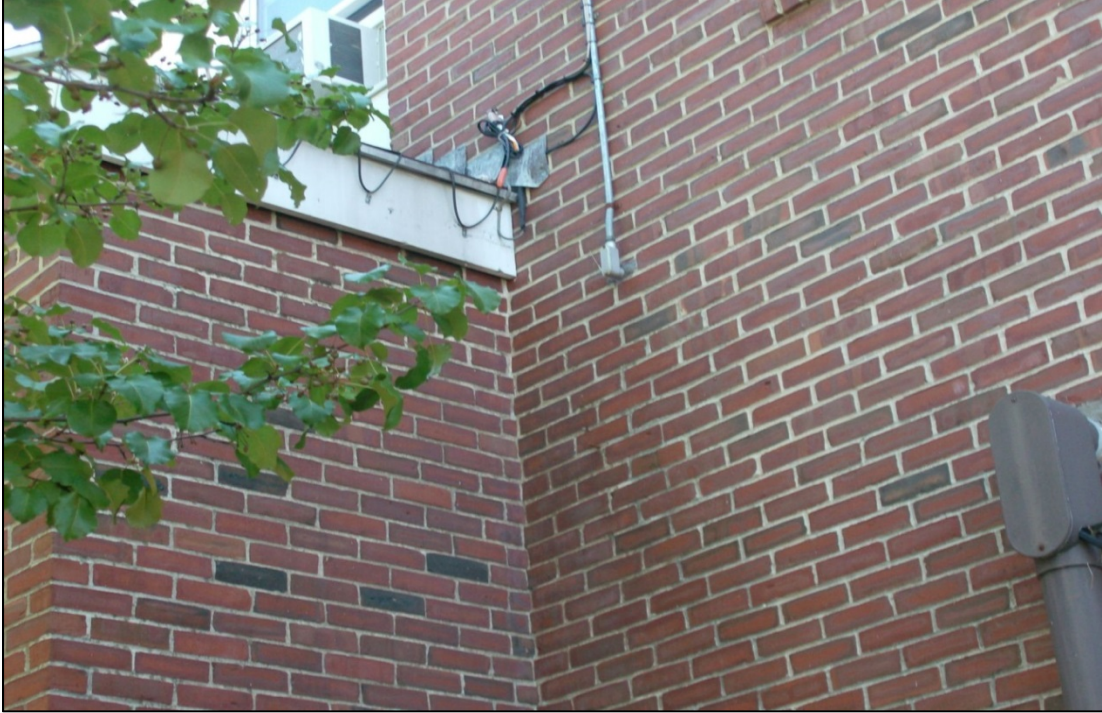
Valley over main entrance. Ice dams are a constant problem, note heat tape.

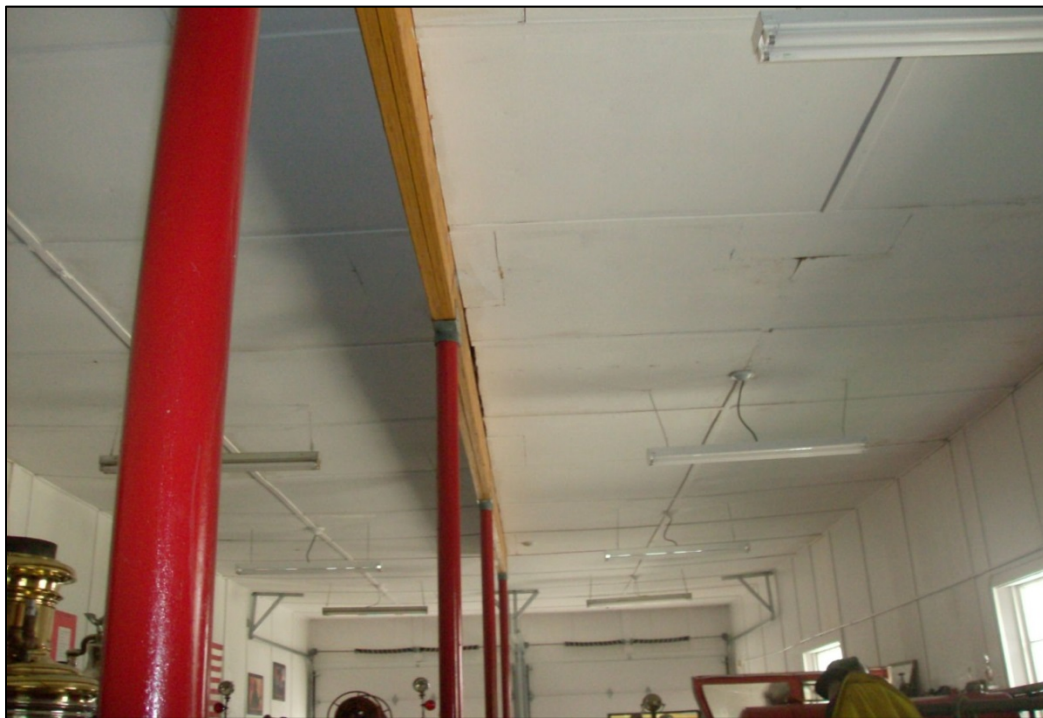
New laminated beam and post added to support ceiling in Fire Museum.

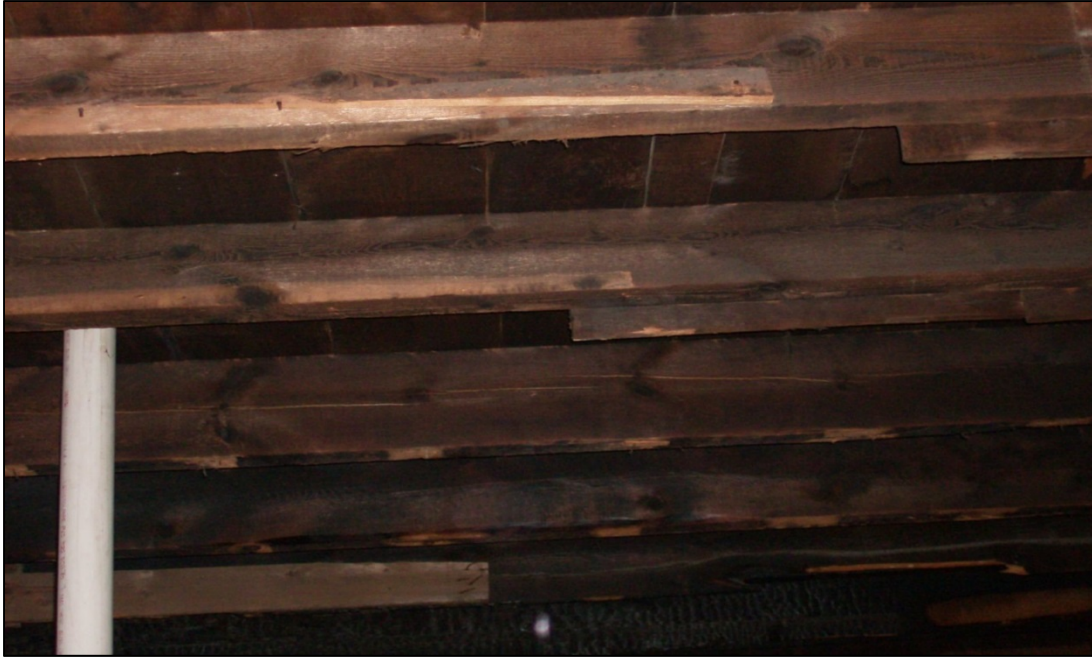
Structurally the building has some sags and dips, but is generally sound. We were able to fully access the space above the ceiling, but photos show signs of fire damage on some of the wood members; however it did not affect the structural capacity of the load carrying members. The Fire Museum ceiling has sagged over the years and a glulam beam with additional support posts were added several years ago.

Former second floor ceiling framing members with slight charring.

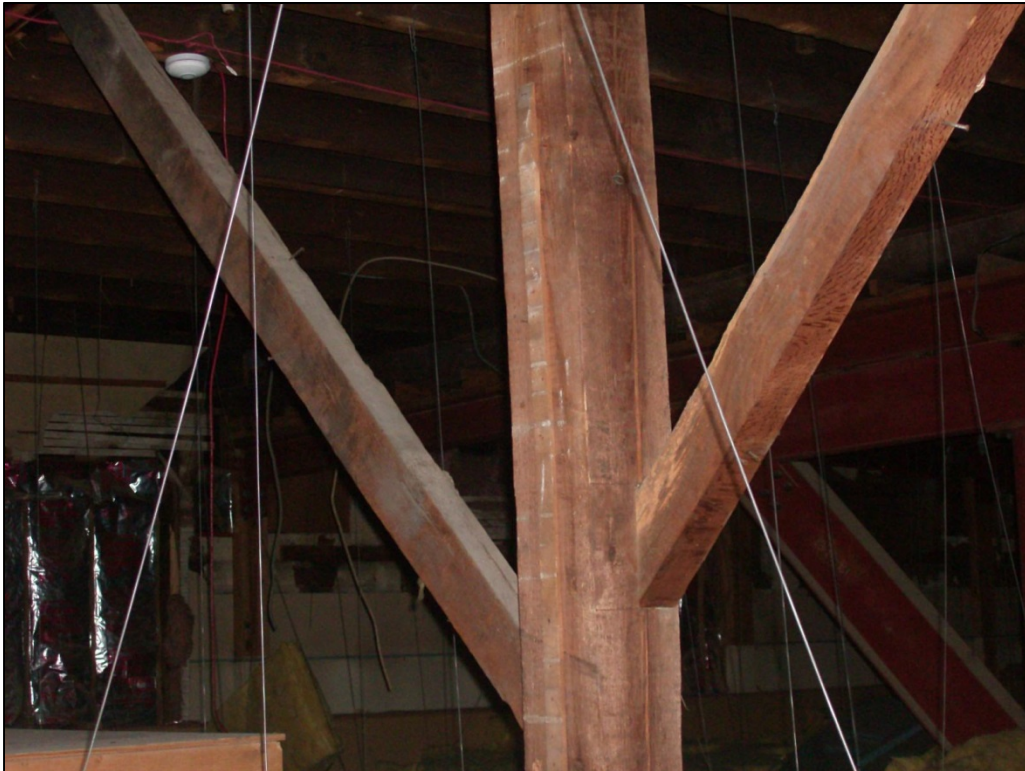
New framing in attic area above Senior Center. Note steel truss in background that was added when second floor walls and floor were removed, and the roof was lowered.

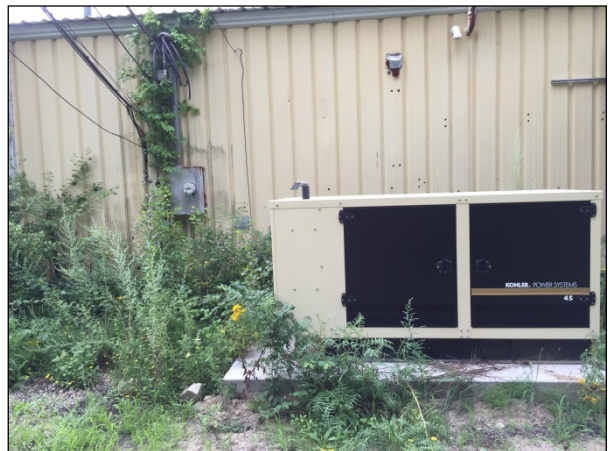
Standby Generator

The building is backed-up by an exterior pad mounted 45 kw, 120/208, 3P natural gas generator located at the back of the building manufactured by Kohler. The generator has a weatherproof enclosure and appears to be in good condition. Automatic transfer switch is located within the back corridor. The ATS switch is manufactured by Kohler.

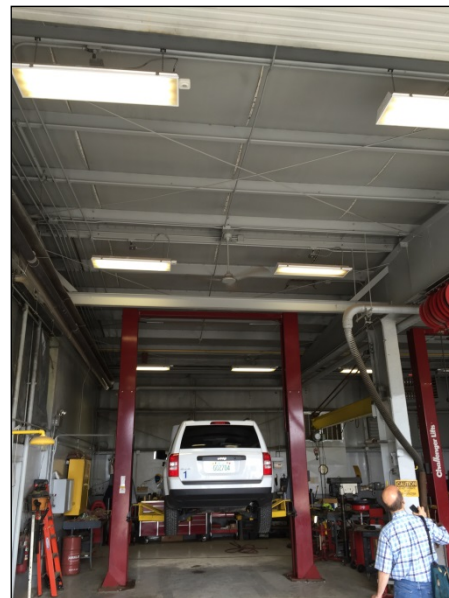
The lighting fixture types consisted of 1x4 pendant mounted and recessed lensed (office/break areas) T8 fluorescent fixtures. The lighting throughout was in fair condition. Existing fixtures shall be cleaned, re-lamped and ballasted as required for best performance. It was noted doors are often open during winter months and cold weather ballast shall be provided.

Pendant Mounted Fluorescent Fixtures with Integral Occupancy Sensors

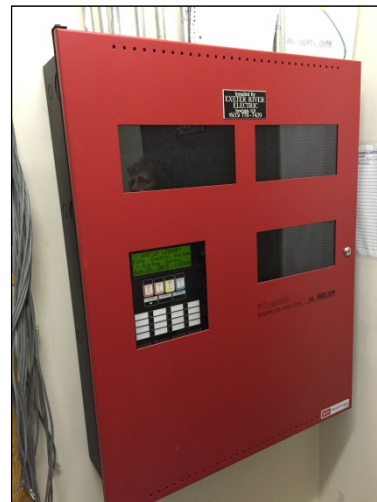
Existing Fire Alarm Control Panel

The fire alarm system is a Mircom addressable fire alarm control panel located on the ground level in the main electric room with an exterior masterbox for connection with the local Fire Department. The FACP appears to be in good condition. The Library is sprinklered. The smoke/heat detector coverage appears to be adequate.

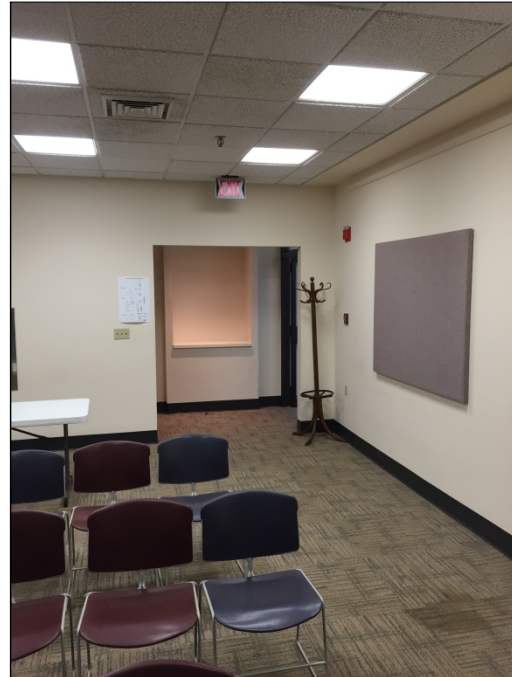
General Recessed Mounted Outlets

It is recommended that additional devices be installed where extension cord and power strips are being utilized.

- Provide additional fire alarm notification devices and replace older devices with new devices.
- Have a licensed electrician conduct a full investigation on the electrical equipment that has been compromised by water damage and replace as required.

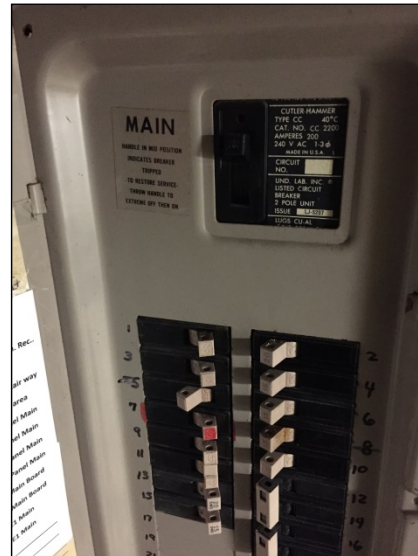
Main Electrical Service Panelboard

The main electrical service is a 200A, 120/240V, 1-phase, 3W. The service enters the building via overhead utility pole. The electrical switch service equipment manufactured by Cutler Hammer with sub-panels located throughout the facility. The sub-panels are in good condition. The main electrical switch gear consisted of a 200A main circuit breaker and various sub-circuit breakers. The electrical panel has space and spares.

It is recommended that the main electrical switch gear remain as installed and updated directory cards be updated for circuit breakers. Load tests shall be performed to provide actual load to determine future expansion, compared with PSNH utility bills.

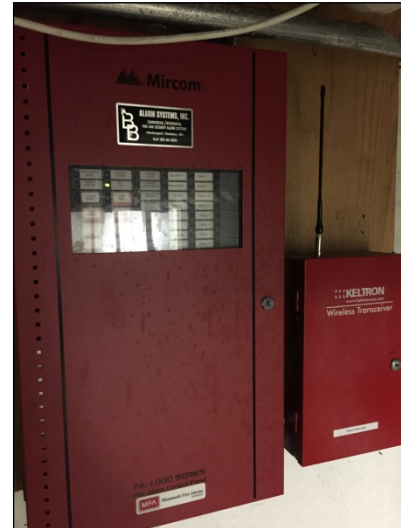
Existing Fire Alarm Control Panel

The fire alarm system is a Mircom zoned fire alarm control panel located on the ground level in the main electric room with a radio masterbox for connection with the local Fire Department. The FACP appears to be in good condition. The center is sprinklered. The smoke/heat detector coverage appears to be adequate. The fire alarm initiation and notification devices were newer ADA type, but the coverage was not sufficient.

No action as this time.

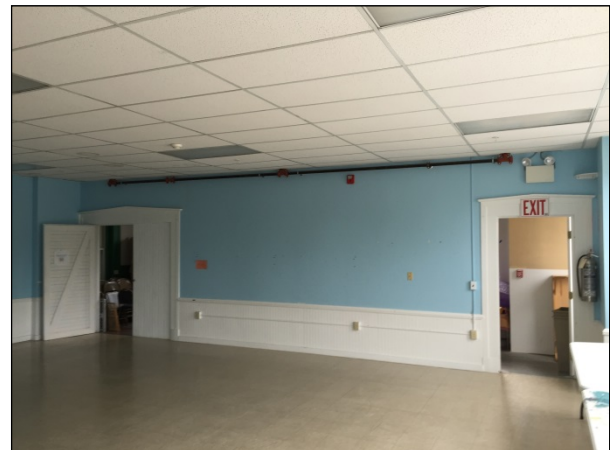
Exit Sign and Remote Battery Unit Heads

There were LED exit signs in good condition and the coverage was adequate throughout.

All existing life safety lighting shall be checked as part of an annual maintenance schedule and replaced as

required. All egress doors shall be provided with illuminated battery backed up LED type exit signs. Provide additional emergency battery units to provide general egress lighting.

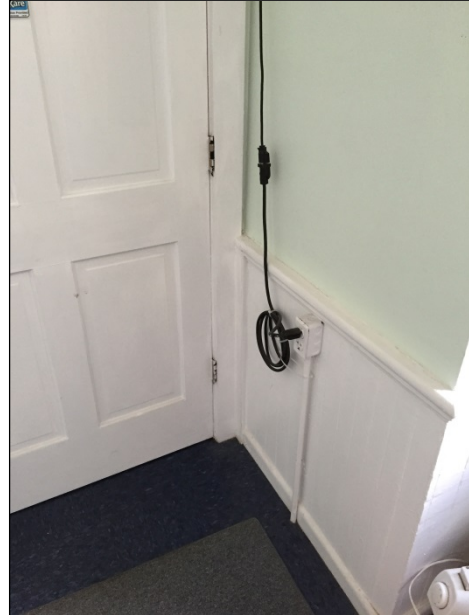
General Surface Mounted Outlets

- Plastic exit signs shall be removed and illuminated exits signs installed at interior egress doors as required.

It is recommended that additional devices be installed where extension cord and power strips are being utilized.

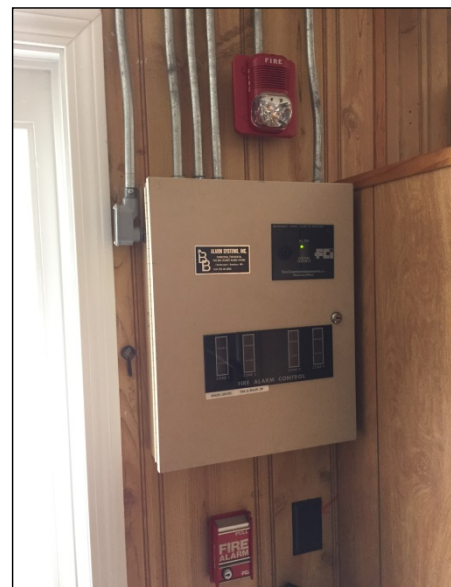
Existing Fire Alarm Control Panel

The fire alarm system is a FCI 4-Zone fire alarm control panel located on the ground level in the main electric room with an exterior masterbox for connection with the local Fire Department. The FACP appears to be in good condition. The center is not sprinklered. The smoke/heat detector coverage appears to be adequate. The fire alarm initiation and notification devices were newer ADA type, but the coverage was not sufficient.

No action as this time.

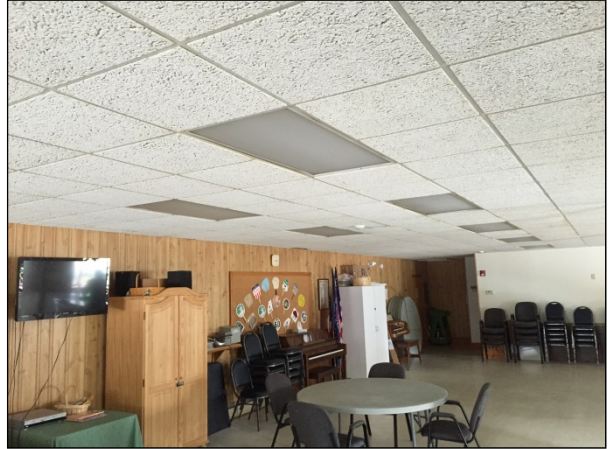
Recessed Mounted Fluorescent Fixtures

The lighting fixture types consisted of 2x4 recessed mounted fluorescent fixtures. The lighting throughout was in fair condition. Existing fixtures shall be cleaned, re-lamped and ballasted as required for best performance.

It is recommended that lights are checked for lamping outage and exterior fixtures cleaned for optimal efficiency. Existing Metal Halide fixtures may be replaced with high efficient LED style lamping. The Town shall review rebate options with PSNH for replacement.

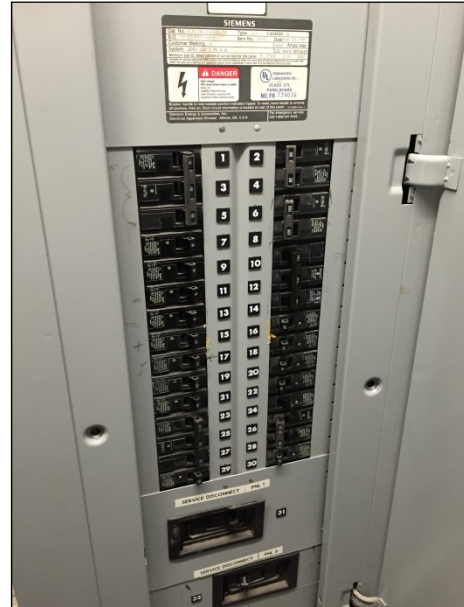
Main Electrical Service Panelboard

The main electrical service is a 400A, 120/208V, 3-phase, 4W. The service enters the building at the basement level via underground duct bank conduit from an overhead utility pole. The electrical switch gear was new service equipment manufactured by Siemens with older sub-panels located throughout the facility. The sub-panels are in good condition. Currently, there is new panelboard upgrades happening on the 2nd floor and the attic space. The main electrical switch gear consisted of a 400A main circuit breaker with various circuit breakers. The electrical panel has no space and no spares.

It is recommended that the main electrical switch gear remain as installed and updated directory cards be updated for circuit breakers. Load tests shall be performed to provide actual load to determine future expansion, compared with PSNH utility bills.

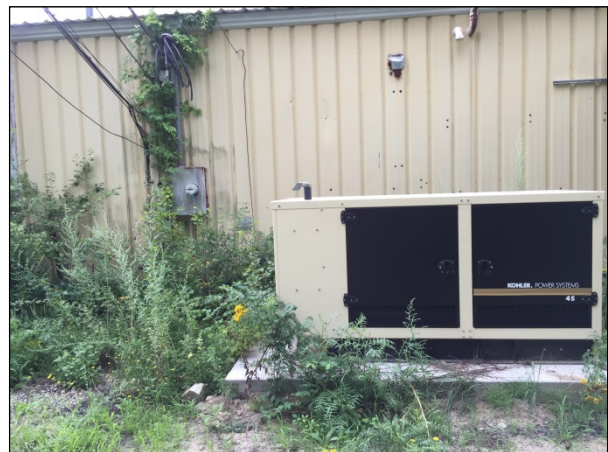
Standby Generator

The building is backed-up by an exterior pad mounted 45 kw, 120/208, 3P natural gas generator located at the back of the building. The generator has a weatherproof enclosure and appears to be in good condition. The automatic transfer switch is located within the back corridor. The ATS switch is manufactured by Kohler.

It is recommended that the standby generator shall exercise on a set schedule by the manufacturer and serviced as required. A load test should be performed to pull data for the amount of load on the generator to allow for any expansion as required. The exhaust for the generator discharges within the enclosure. This unit is adjacent to operable windows and HVAC air intakes. The generator exhaust shall run to above the roofline with a stack. International Building and International Mechanical codes required exhaust to discharge more than 10'-0" from operable windows and/or fresh air intakes.

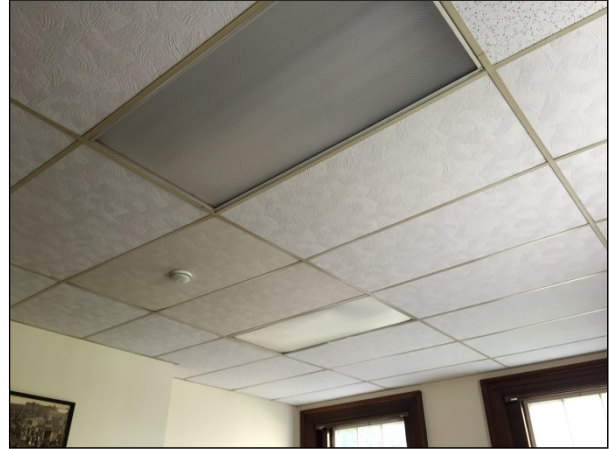
Recessed Mounted Fluorescent Fixtures

The lighting fixture types consisted of 1x4 surface mounted strip fixtures in the basement, and recessed mounted lensed fluorescent fixtures in the office areas. Lighting fixtures contained T8 fluorescent lamps. The lighting throughout was in fair condition. Existing fixtures shall be cleaned, re-lamped and ballasted as required for best performance. It was noted doors are often open during winter months and cold weather ballast shall be provided.

It is recommended that lights are checked for lamping outage and exterior fixtures cleaned for optimal efficiency. Existing Metal Halide fixtures may be replaced with high efficient LED style lamping. The Town shall review rebate options with PSNH for replacement.

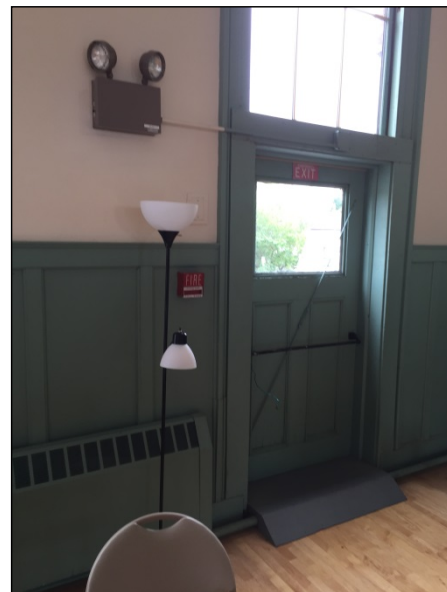
Existing Fire Alarm Pull Station

The fire alarm system is a Gamewell FCI zoned fire alarm control panel FACP located in the basement. There is a remote annunciator with indicator lights in the front lobby. A radio masterbox for connection with the local Fire Department is located adjacent to the FACP. The FACP is in fair condition. The building is sprinklered. The smoke/heat detector coverage was adequate except for common corridors. The fire alarm initiation and notification devices appear to be in good condition, but the coverage was not sufficient. The pull stations were noted to be mounted too high to meet ADA requirements. Additional devices shall be provided in bathrooms, office areas, breakrooms and corridors.
